# A comparative analysis of the stability of a slope in an overconsolidated clay pit based on CPT and DMT measurements

# H. Peiffer

Laboratory of Geotechnics, Department of Civil Engineering, Ghent University, Ghent, Belgium

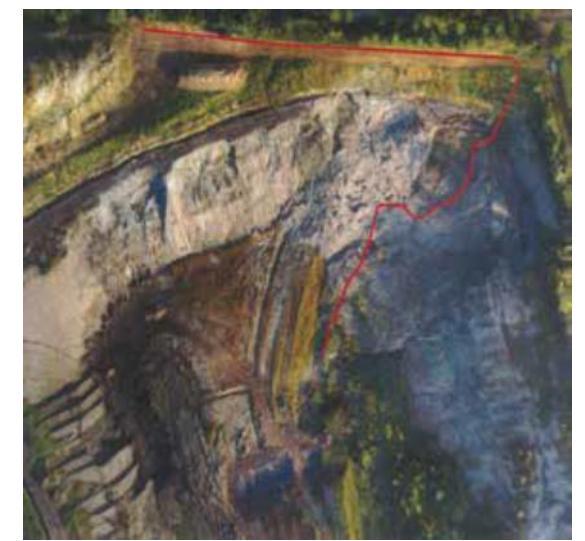
In the figures 2 and 3 a general impression of the sliding and the soil movement is presented. A zone of 100 m by 50 m started to move resulting in a downward movement of about 9 m in the corner of the pit. After the first sliding in the northwestern part of the pit a monitoring program was set up. The monitoring consisted out of the execution of CPT-tests and DMT-test. Besides these tests, also the water pressures were measured on a regular base

Figure 2. Photographic impression of the sliding

The analysis resulted in a design where a deep drain has to be installed at a depth of 5 m., as shown in the Fig. 2. This drain was installed in November 2015. The red line in figure 2 is the position of the drain in plan view. After the installation of this drain, there was an immediate effect on the depth of the groundwater. The original depth of 1,5 m increased to a depth of about 4.5 m. The safety of the slope stability increased from 0,9 to 1.31.

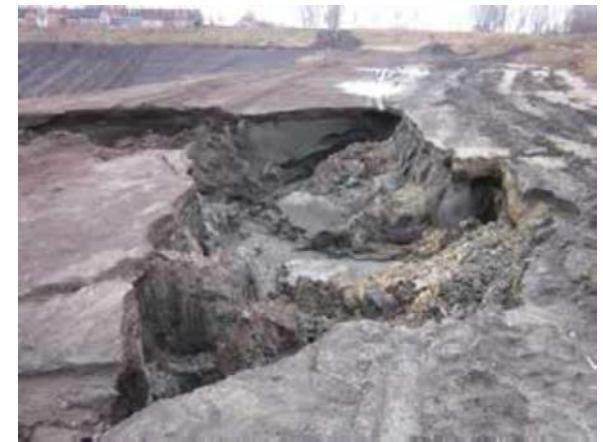
Figure 3. Detailed impression of the instable slope

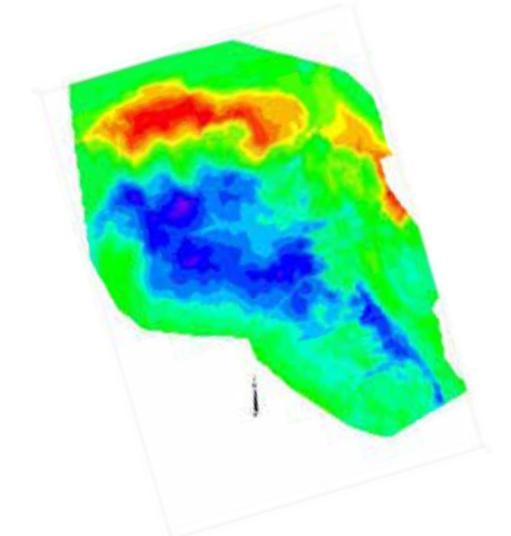
Figure 4. Topographic survey of the soil movement

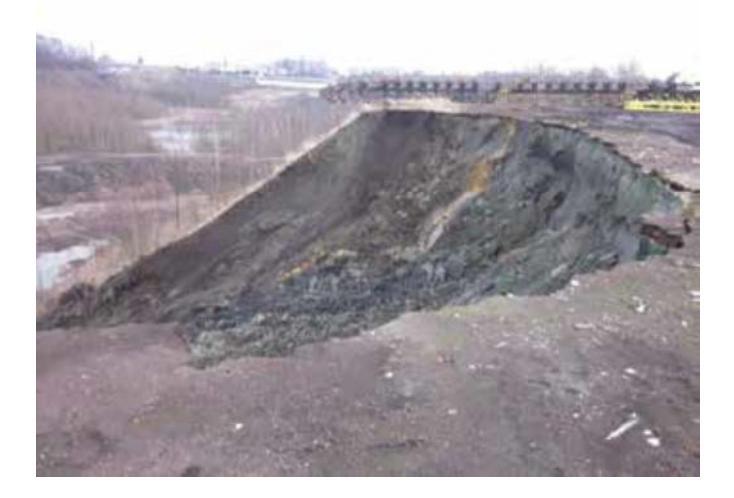
In the second half of 2013 a more important slide occurred in the neighborhood of point 5 on figure 5. The number 5 refers to DMT 5 executed in the beginning of 2014 at a distance of 5 m from the top of the slope.

In the figure 8 a photo of the slide is presented. The sliding occurred in the quaternary layer until a depth of about 1.5 m in the Boom clay.

Figure 8. Photo of the unstable zone after sliding

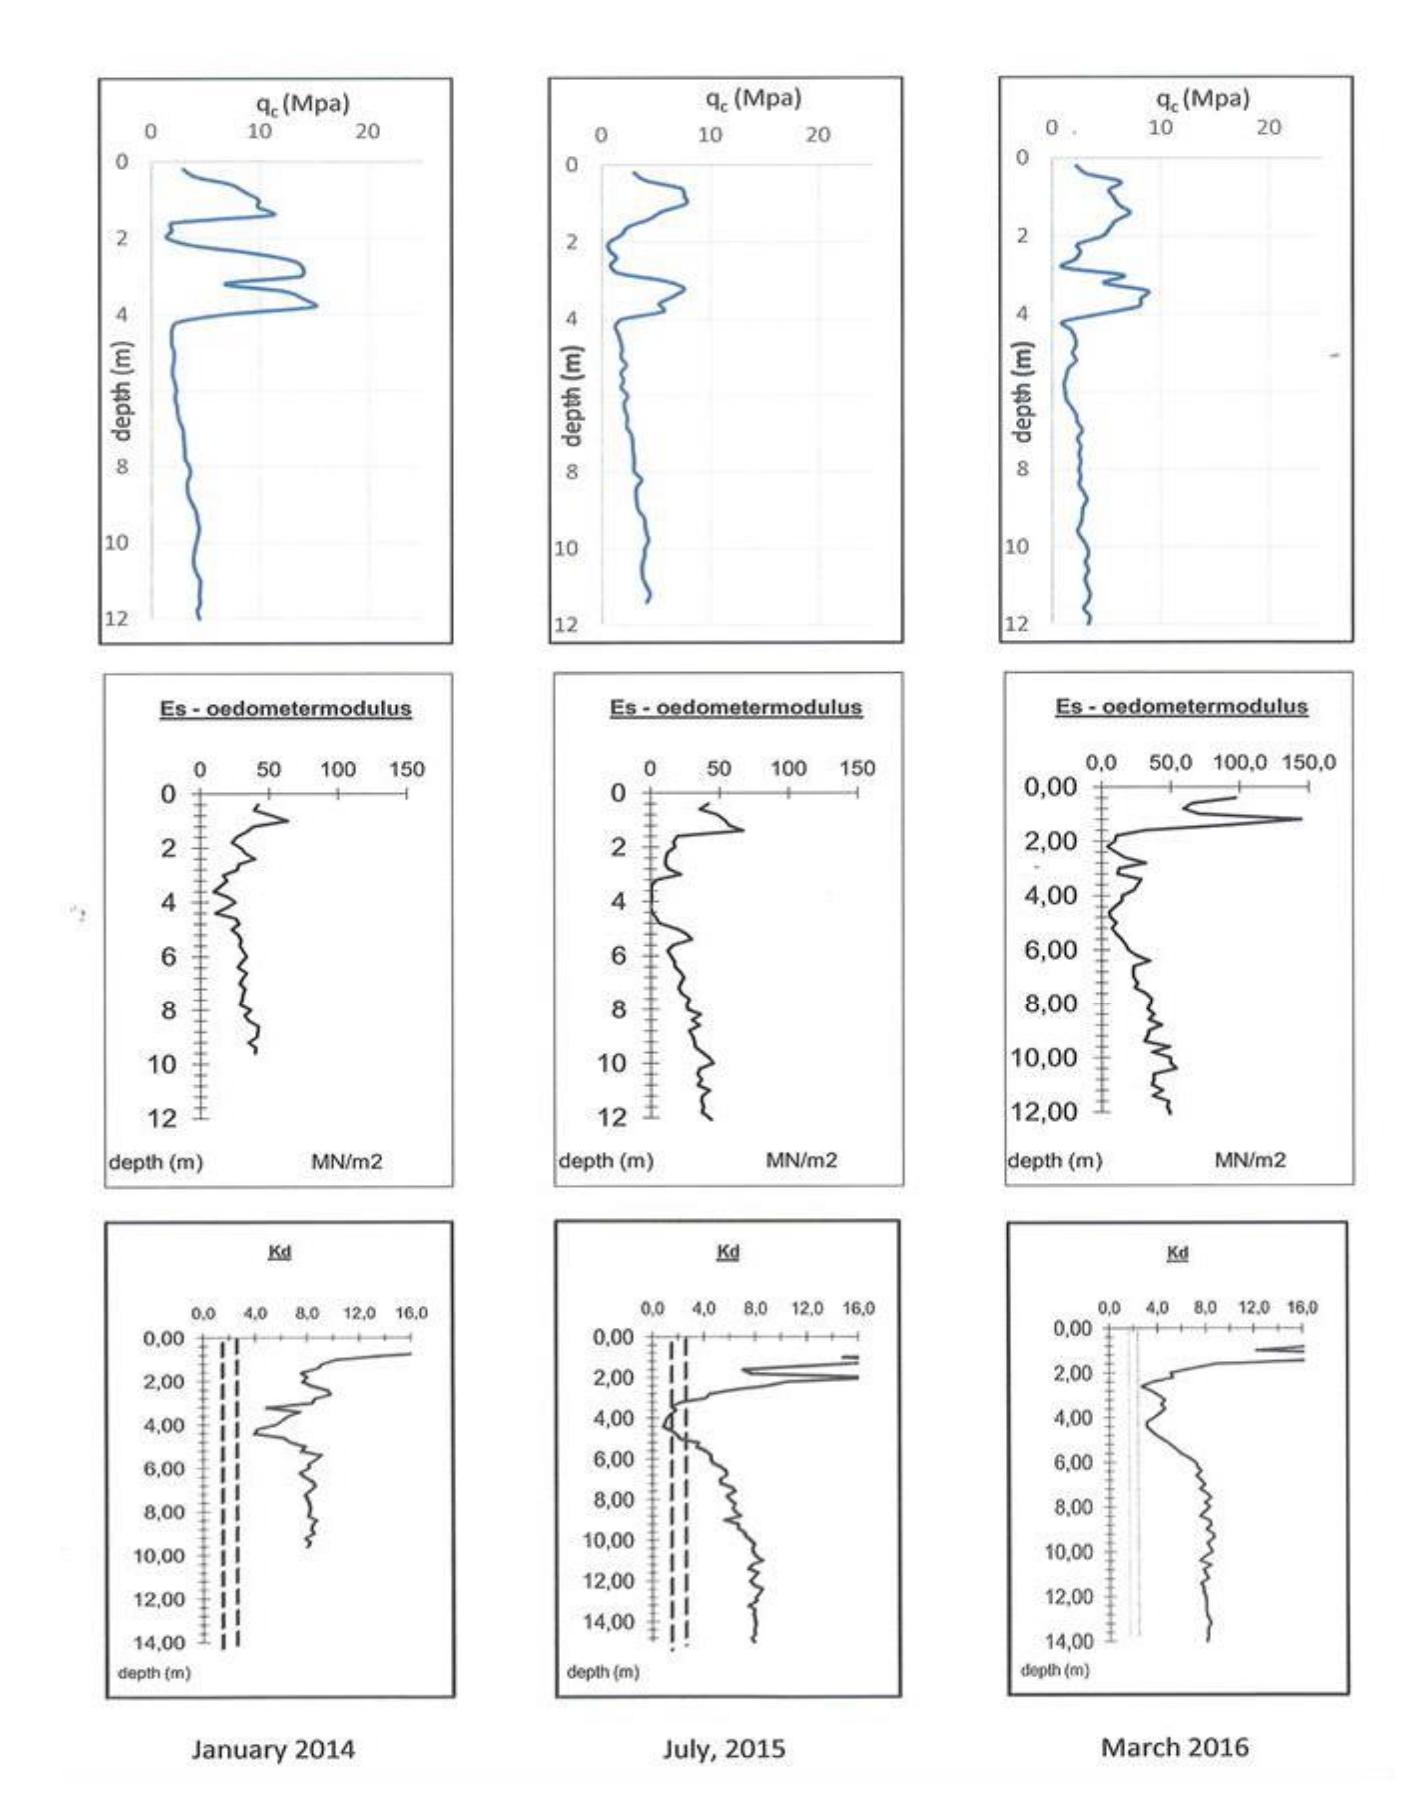
Figure 10. Results of CPT and DMT

In the test diagrams one can distinguish the upper quaternary sandy silt layer. In the  $K_D$ -graph one can see that two points (one in a weaker point in the quaternary deposit and one at the interface between the quaternary layer) show a lower value of  $K_D$ . The CPT diagram shows also the presence of a weaker layer at depth of about 2m. The DMT-results show a decrease in horizontal stress at these point.

The layer between these two points became unstable in June 2014, resulting in an important sliding. One can see on the diagrams of figure 10 (July 2014) that the K<sub>D</sub>-value became lower than 1.8, referring to unstable soil conditions. The failure occurred in this zone and affected a slip layer with a thickness of about 1.5 m. Although the cone resistance decreased with a factor about 2, and a significant decrease of qc between 2 and 4 meter can be seen in this layer, the sliding. It is also important to notice that the KDvalues below the sliding zone decreased till a depth of about 5 m below the sliding surface. It is interesting to see which way the stresses changed after the sliding. In the last column of figure 10, the results are presented for the measurements carried out in March 2016. Remediation works were done in October-November 2014 (see 6.).

The q<sub>c</sub>-value did not change in an important way. Out of the K<sub>D</sub>-diagram it become clear that the K<sub>D</sub>-values exceeded the critical value 1.8. For the clayey layer the measurement reflects actually a normally consolidated soil. For the intermediate sandy silt layer, one can see a slightly overconsolidated soil condition. The difference between the measurements of July 2014 and March 2016 can be explained by the presence of excessive pore pressures, resulting in lower values of K<sub>D</sub> in the sandy silt layer in the sliding layer.

After consolidation a residual part of the original overconsolidation did appear again. The soil conditions after sliding and reconsolidation can be measured more clearly using the dilatometer.

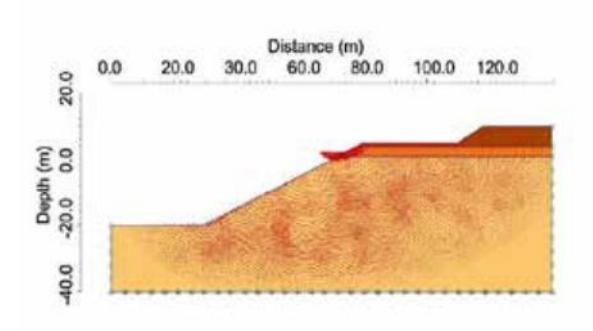
Figure 11 – PLAXIS-analysis

In order to get a better understanding of the effects resulting in this instability and in order to design an appropriate remediation, additional investigation was done to determine the design soil characteristics (CPT-tests and laboratory tests (triaxial tests, oedometer tests)). This analytical and numerical analysis is not discussed in detail in this article. Out of the theoretical analysis it became clear that the effect of the groundwater pressures on the horizontal equilibrium was dominant.

The Fig. 11 presents the calculated critical horizontal disequilibrium due to the presence of the groundwater out of an equilibrium analysis the zone within the most critical global sliding surface. But in the upper part of this zone the equilibrium is broken in the upper layer (lower part of the quaternary deposit and top layer of the Boom clay (big red arrows)). In reality it could be seen that the sliding in the upper part of the Boom clay was more pronounced than in the analysis made with Plaxis.
