23. Hydro(geo)logy and impact of soil and water conservation measures on the hydrological response in May Zeg-zeg catchment

(After Walraevens et al. (2009), Nyssen et al. (2010), Vandecasteele et al. (2011))

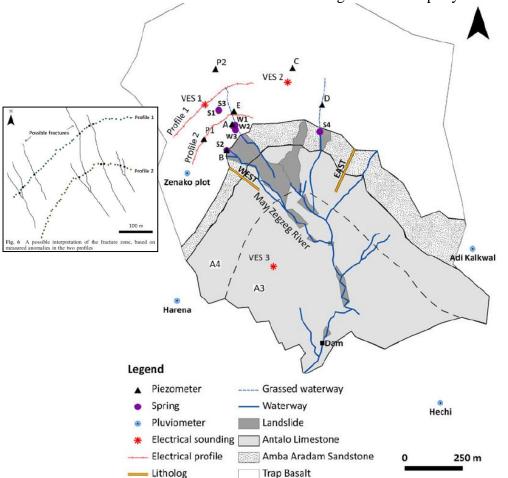
Fig. 3 Geological map of the May Zegzeg catchment. The sub-division of the Antalo Formation into units A3 and A4 is represented *black dashed line*. The profiles along which lithologs were taken on both sides of the catchment are indicated *Fig.* 2.

A geological map was produced through geophysical measurements and field observations, and a fracture zone identified in the north west of the catchment (Fig. 2). A perched water table was found within the Trap Basalt series above the laterized upper Amba Aradom Sandstones (Fig. 3). A map of this water table was compiled. Water-level variation during the measurement period was at least 4.5 m (Fig. 4). Variation in basal flow for the whole catchment was measured at the dam near the outlet in the rainy season of 2006 (Fig. 5 and 6) and varied between 12 and 276 m³/day. A groundwater flow model was produced using Visual MODFLOW using parameters for hydraulic conductivity (Table 2, Fig. 7), indicating the general direction of flow to be towards the south, and illustrating that the waterways have only a limited influence on groundwater flow (Fig. 9). The soil water budget was calculated for the period 1995– 2006, which showed the important influence of the distribution of rainfall in time (Fig. 8). Although Hagere Selam received some 724 mm of rainfall per year over this period, the strong seasonal variation in rainfall meant there was a water deficit for on average 10 months per year.

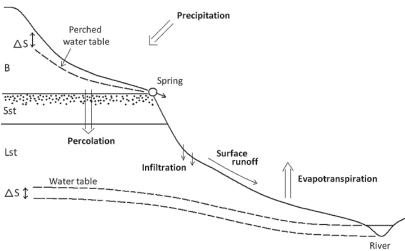
Fig. 4 The hydrological cycle represented in a schematic cross-section of the May Zegzeg catchment. Abbreviations used are basalt (*B*), sandstone (*Sst*) and limestone (*Lst*) for the lithologies, and ΔS for the change in soil water storage. Not to scale *Fig. 3*.

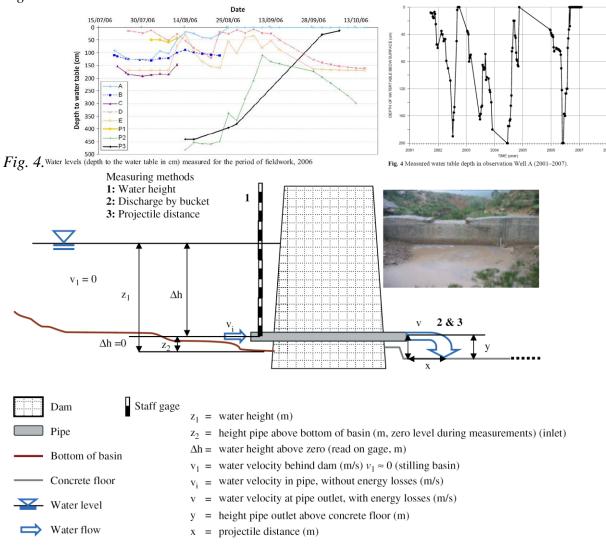
Schematic representation of the cement dam where runoff measurements were made at the catchment outlet (for location see Fig. 5.

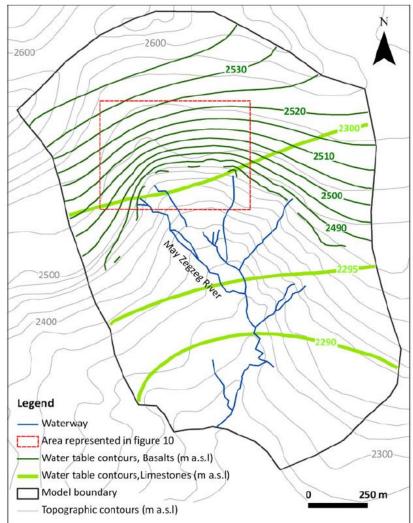
Fig. 9. Calculated piezometric levels in the vertisols/Trap Basalts and Antalo Limestone. The area for which the

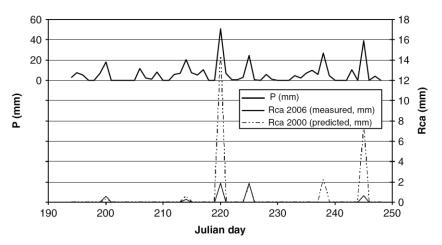
Fig. 10.

Runoff depth at catchment scale (R_{CA}), as measured in 2006 (after catchment management) and predicted for 2000 (before catchment management), based on 2006 rainfall data (P)

Against this general background of catchment hydro(geo)logy, changes in the hydrological response of the catchment after catchment management in 2004 were investigated. Impact studies of catchment management in the developing world rarely include such detailed hydrological components. The management included various soil and water conservation measures such as the construction of dry masonry stone bunds and check dams, the abandonment of post-harvest grazing, and the establishment of woody vegetation. Measurements at the catchment outlet (Fig. 5) indicated a runoff depth of 5 mm or a runoff coefficient (RC) of 1.6% in the rainy season of 2006. Combined with runoff measurements at plot scale, this allowed calculating the runoff curve number (CN) for various land uses and land management techniques (Table 3). The pre-implementation runoff depth was then predicted using the CN values and a ponding adjustment factor, representing the abstraction of runoff induced by the 242 check dams in gullies. Using the 2006 rainfall depths, the runoff depth for the 2000 land management situation was predicted to be 26.5 mm (RC = 8%), in line with current RCs of nearby catchments (Fig. 10).

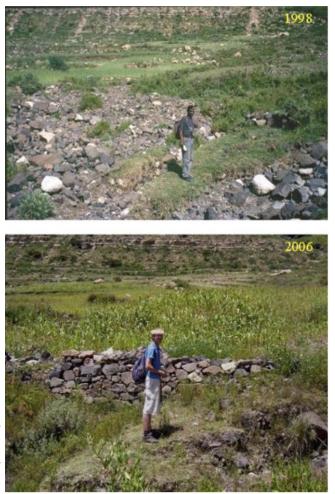
Fig. 11.

Figure 10. Part of the lower gully system of MZZ before (1998) and after catchment management (2006). Both photographs were taken in August, during the main cropping season. Due to direct runoff abstraction in the upper catchment, gully bed morphology had stabilized and was managed by farmers who could confidently grow crops in the former gully bed. Note also shrub regrowth and slope stabilization on the steeper slopes in the background
