# DESIGN CONSIDERATIONS FOR SHEAR FAILURE OF FLAT CONCRETE SLABS EXPOSED TO FIRE

Emmanuel Annerel<sup>a,b</sup> and Luc Taerwe<sup>a</sup>

<sup>a</sup> Ghent University, Faculty of Engineering and Architecture, Department of Structural Engineering, Magnel Laboratory for Concrete Research, Technologiepark Zwijnaarde 904, B-9052, Ghent, Belgium; emmanuel.annerel@ugent.be, luc.taerwe@ugent.be

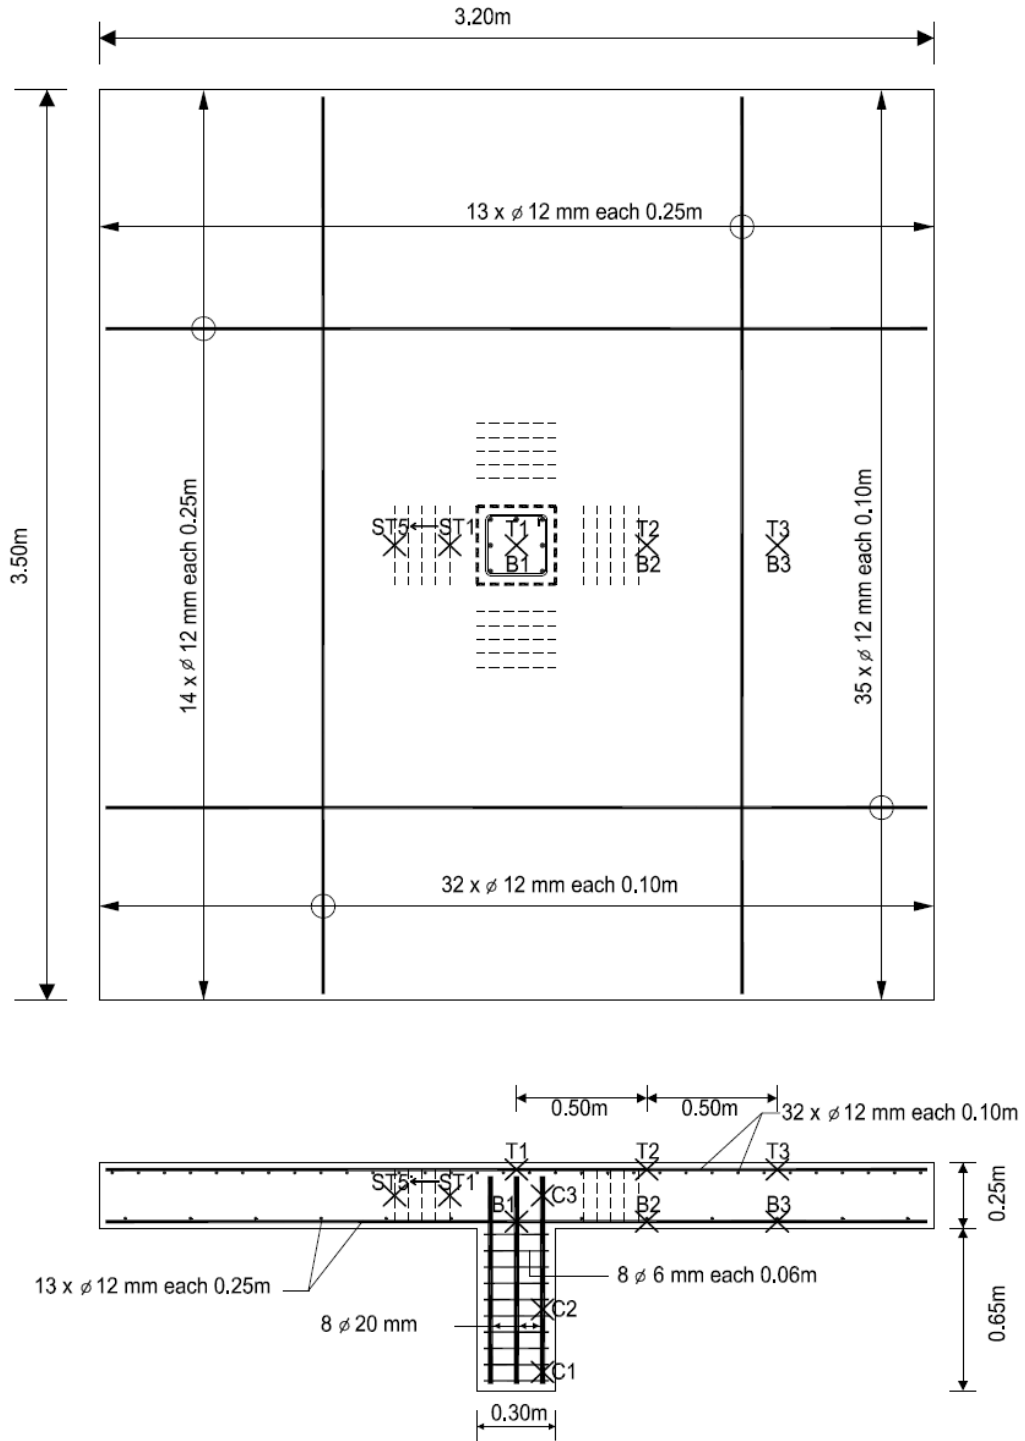
The slab has reinforcement bars with a diameter of 12 mm, positioned in 2 orthogonal directions with a spacing of respectively 0.10 m at the top and 0.25 m at the bottom (see Figure 1). The column has 8 longitudinal rebars, from which 4 are located at the corners and the other 4 are positioned in between the corner bars. Stirrups with a diameter of 6 mm are used along the height of the column with 60 mm spacing.

**Fig. 1** Geometric characteristics of the test slabs and thermocouple locations

Thermocouples are embedded at different locations of the reinforcement (see crosses in Figure 1).

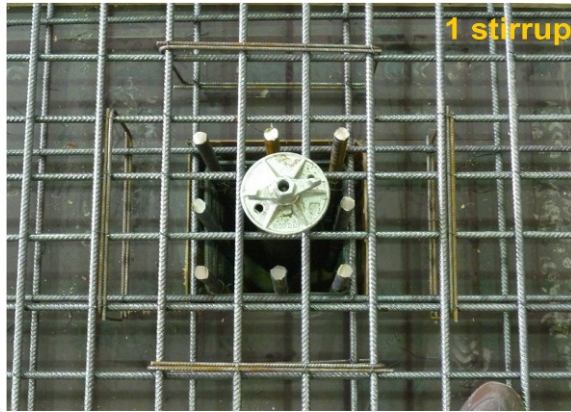
Four types of slabs are cast which differ in amount of shear reinforcement. The first slab has no shear reinforcement (slab S0), the other types have respectively 1 (S1), 2 (S2) and 5 (S5) stirrups at each of the four column sides. These stirrups consist of two U-shaped legs that are connected to the main reinforcement and have a diameter of 6 mm (see Figure 2). The first stirrup is in all cases positioned at 106 mm ( $0.5 \times$  effective depth of the slab) from the column face. In case of S2, the second stirrup is positioned with a spacing of 106 mm. In case of S5, all the stirrups are placed within 318 mm ( $1.5 \times$  effective depth of the slab), resulting in intermediate spacings of 53 mm. Figures 2 & 3 illustrate the position of the stirrups for slabs S1 and S5.

**Fig. 2** Top view of shear reinforcement of slab S1

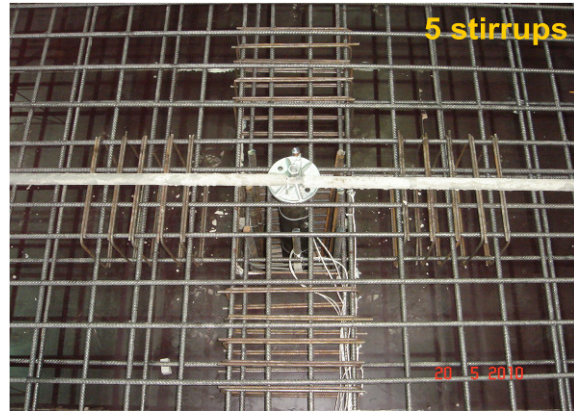
**Fig. 3** Top view of shear reinforcement of slab S5

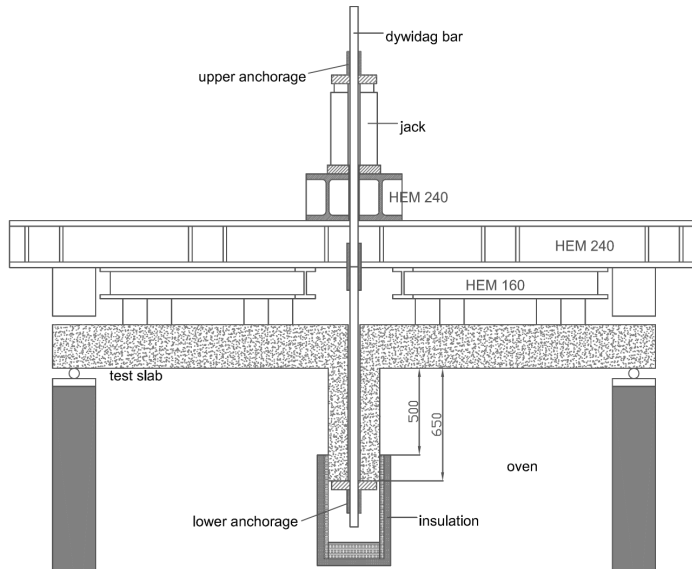
A special loading frame is constructed to allow the concrete slabs to be loaded and tested for punching failure at high temperatures. The difficulty is to have a loading system positioned on top of the slab, since it was not allowed to load from the furnace floor. Therefore, the slab and column have a central opening which allows to position a high strength steel bar (Dywidag) that is anchored at the lower side

of the column stub and on top of a hollow hydraulic jack (capacity 1000 kN) which is supported by a series of steel beams (Figures 4 & 5). The load applied by the jack is transferred to the slab by 8 loading points, distributed symmetrically along the perimeter of a circle with a 1.3 m radius. To protect the steel bar and its anchorage from excessive heating during the fire test, the column was insulated by two layers of calcium silicate boards and mineral wool. During the fire tests, two slabs are simultaneously tested.

**Fig. 4** Cross section of test setup

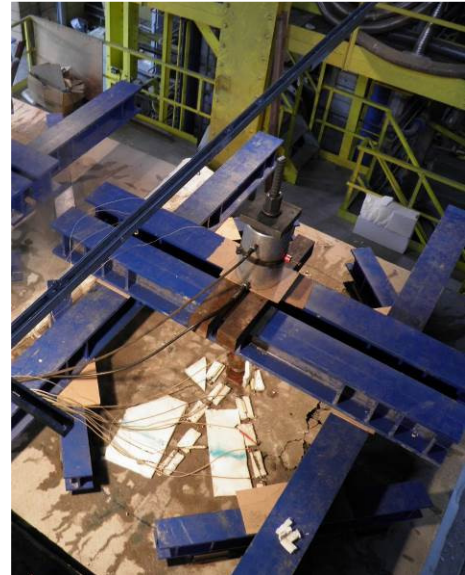
**Fig. 5** Overview of the test setup at high temperatures

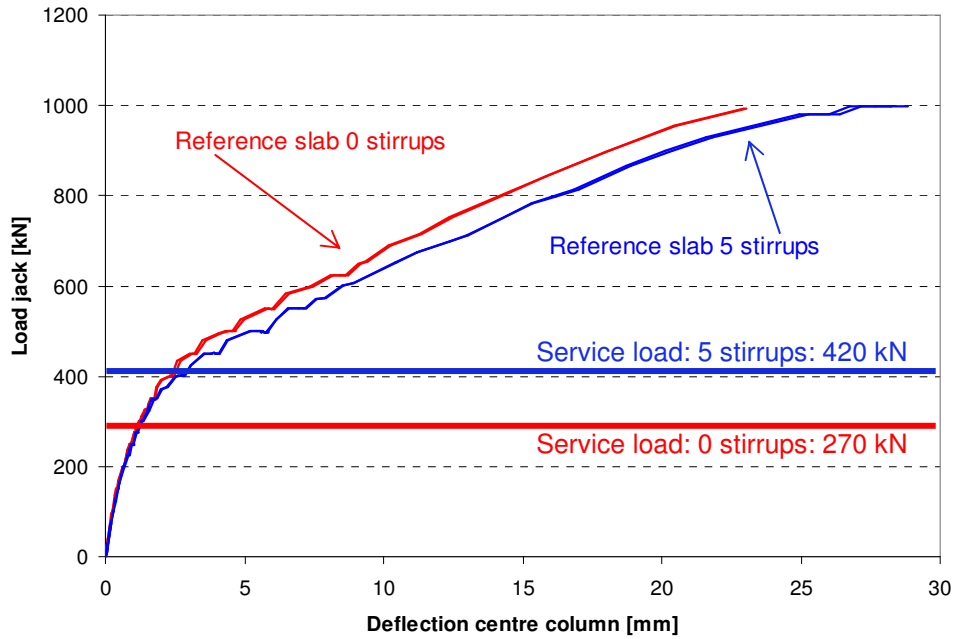
During the loading test the slab is bending over the column. In this way, the slab is only supported at its four corners. Figure 6 shows the maximum vertical displacement of the slab with increasing load (situated at the centre of the slab). For a given load step, the deformations are larger for slab S5 than for S0. As is visible on the graph, the failure load of about 1000 kN is 2.5-3.7 times larger than the service load according to EN 1992-1-1.

**Fig. 6** Load-deflection curve of slabs S0 and S5 tested at ambient temperature

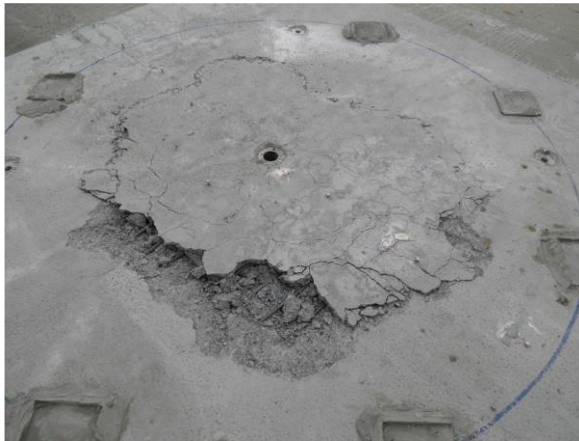
Figures 7 and 8 show the damage to the slabs after fire and loading till failure. A symmetrical punching cone is observed, as well as spalling of the column corners and the bottom of the slab. More details about the spalling damage is given in section 4.

**Fig. 7** Punching cone after fire test of slab S1 (top view)

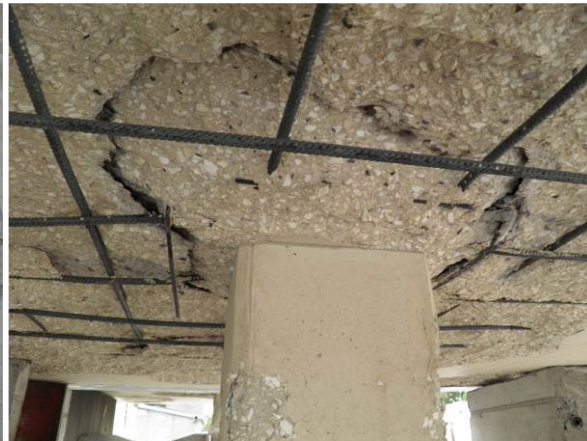
**Fig. 8** Punching cone after fire test of slab S1 (bottom view)

One slab without stirrups (S0\_20°C) and one slab with 5 stirrups (S5\_20°C) are tested for punching shear at ambient temperatures. The slabs are loaded in subsequent loading steps of about 50 kN till failure. After each loading step, the slab is inspected for cracks which are indicated on the slab surface by a marker. The first visible cracks appear at the top of the slab at about 100 kN for the slab without stirrups (Figure 9), and at 250 kN for the slab with 5 stirrups at each column side. These cracks start from the centre of the slab and increase in size and number with increasing load. Those radial cracks are formed due to the bending of the slab over the column. Yielding of the longitudinal steel bars will influence this crack pattern. While those bending cracks increase in size and number, tangential cracks start from the column-to-slab connection and a punching cone starts to develop. Punching failure occurs when this cone is fully developed over the thickness of the slab and the cone is literally punched through the slab, as is illustrated in Figure 8.

Concrete spalling occurred at the column corners near the slab surface (see figure 8). Furthermore, a total loss of the concrete cover of the bottom reinforcement of the slabs was found in a region of about 800-1000 mm surrounding the column, resulting in naked bottom reinforcement and stirrups. Closer to the column stub, maximum spalling depths of up to 100 mm were measured. This spalling damage

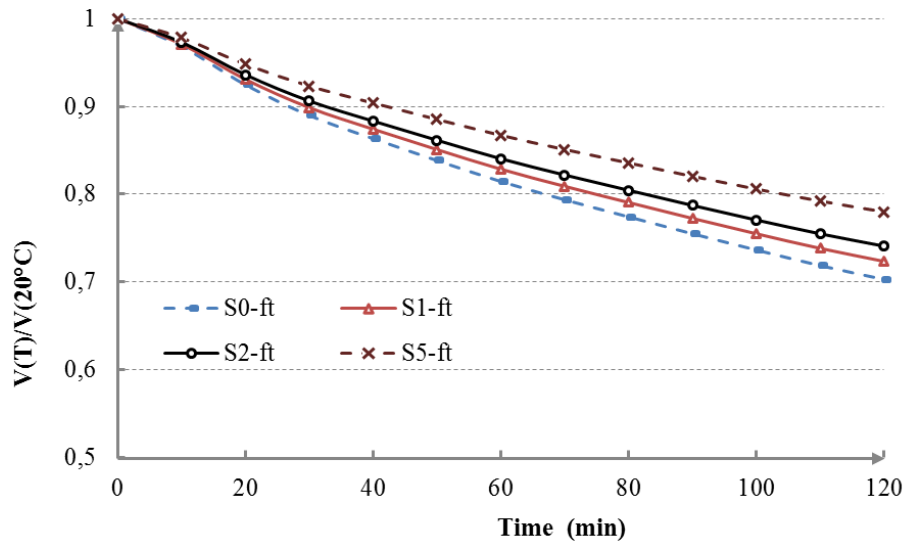
Figures 9 and 10 show the loss of punching resistance upon heating, given as the ratio of the punching strength at high temperatures  $V(T)$  and at ambient temperature  $V(20^\circ\text{C})$ .

Figure 9 shows the punching strength loss in case no spalling is considered. After 120 minutes of ISO 834 fire, a punching strength loss of up to 20-30% is found. These losses are smaller than the experimental value of about 40% (found for slabs S0 and S1).

**Fig. 9** Evolution of the punching shear resistance upon heating

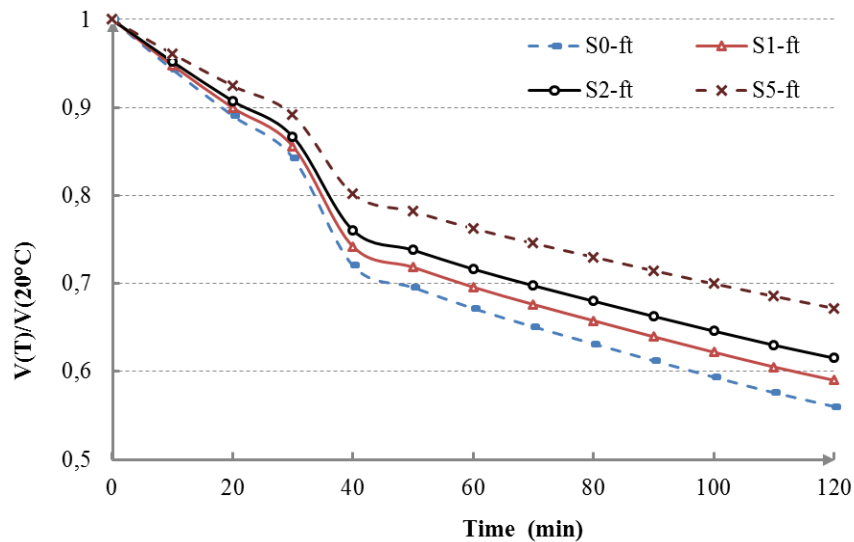
To obtain a better agreement with the fire test results, the experimentally observed spalling of the concrete cover of the bottom reinforcement is introduced in the calculation as a gradual loss of the outer layers. This spalling is adopted as the gradual removal of the concrete layers that exceed a temperature of 350°C from the thermal and mechanical calculation. This spalling criterion was proposed by Kodur & Dwakat (2008) on the basis of a number of tests. This process is continued till the total concrete cover of 25 mm is removed. Figure 10 shows the calculation results, from which the influence of the loss of the bottom concrete cover on the punching shear resistance is clear. An additional punching shear loss due to spalling of about 10-15% is found. At 120 minutes, the punching strength loss reaches about 40% for the slabs with 0 and 1 stirrups at each side of the column, which is in good agreement with the fire tests.

**Fig. 10** Evolution of the punching shear resistance upon heating when spalling is considered

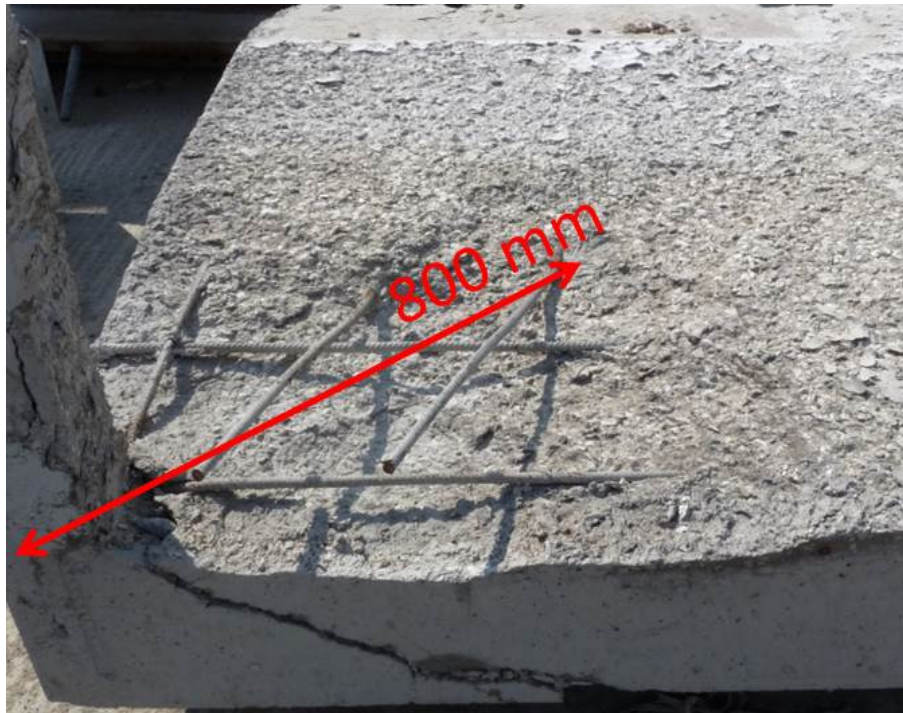
was observed for all slabs tested for fire. Figure 11 illustrates the typical spalling behaviour, as observed for slab S0.

**Fig. 11** Spalling damage of slab S0

Contributions to the observed spalling, could be found in the initial moisture content of the concrete at the start of the fire of about 3.5-4.0%, as well as the expected high compressive stresses near the concrete surface. Those compressive stresses are a result of both the mechanical loading to service load at the beginning of the fire test, and the restraint of the thermal expansion of the outer heated layers by the inner less heated layers.

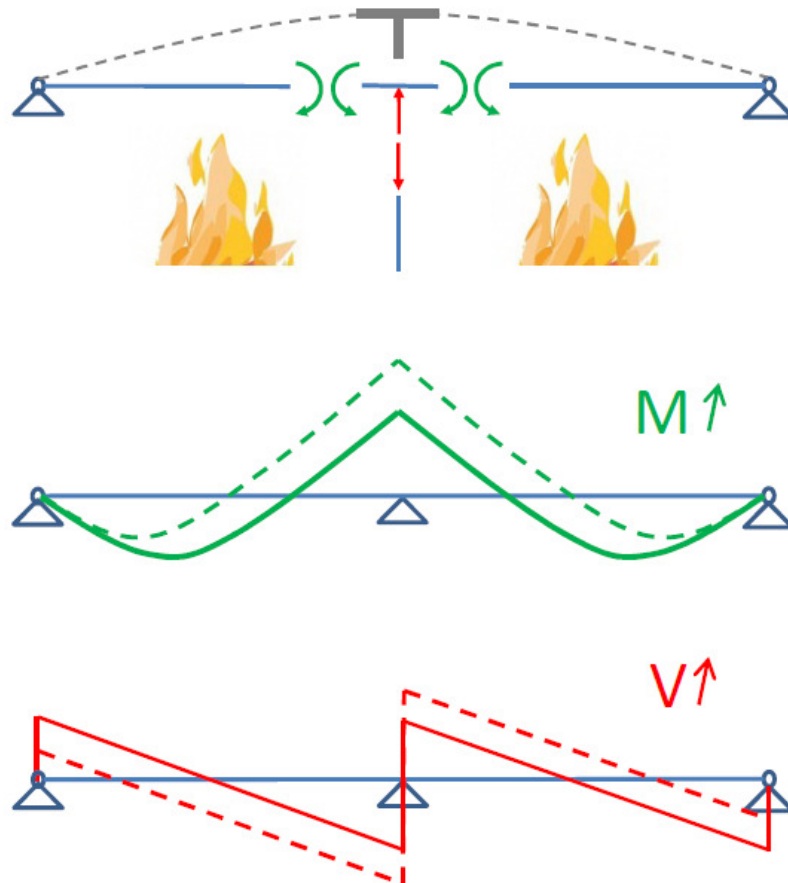
Firstly, the load can increase due to restraint of the thermal deformation of the concrete slab. Because of one sided heating and the low conductivity of concrete, a thermal gradient will appear over the slab thickness. Consequently, the outer concrete layers will expand more than the inner layers, which will result in a thermal curvature towards the fire. At the column-slab connection, these rotations are restrained, resulting in an increased supporting moment, and thus also an increase of the punching shear load (illustrated in figure 12).

**Fig. 12** Increase of axial load due to restraint of thermal deformations

The effect of the restraint of the thermal curvature of slabs is studied in Annerel & al. (2013). A finite element analysis is performed on a typical underground parking structure consisting of a flat slab supported by two rows of square columns and four perimeter walls. A reasonable structural slab

slenderness of 23 is considered. A fire scenario of subsequently burning of 6 cars is used, resulting in maximum temperatures of about 1150°C and a total fire duration of close to 120 minutes. Only the slab is modelled, whereas the column tops are considered as fixed supports in vertical direction. In case a temperature dependent elastic modulus is used, an increase of the axial load at high temperatures of up to 2.3 times the axial load at ambient temperatures is found for the worst loaded columns. The model does not consider concrete cracking and rebar yielding which could reduce the restraining effect. Also, Kordina (1993) reports for a specific fire scenario an increase of the column load to a value of between 1.15 and 1.70 times the axial load at ambient condition, depending on the location in the grid of 6 by 6 m.
