The use of a DMT to monitor the stability of the slopes of a clay exploitation pit in the Boom Clay in Belgium

ABSTRACT: *In Belgium the Boom Clay is a well know overconsolidated clay formation. This Tertiary clay, with a same geological origin as the London Clay, is used for the fabrication of bricks, roofing tiles, expanded clay,.....*

In the article is described how the DMT can be used to evaluate the stability of slopes, to determine the risk of instability and how the cause of the failure directly could be related to the results of the DMT-measurement. The results of the tests before the period of instability, during the period of instability and after stabilization are discussed. The K_D -value is a representative value to judge the risk of instability.

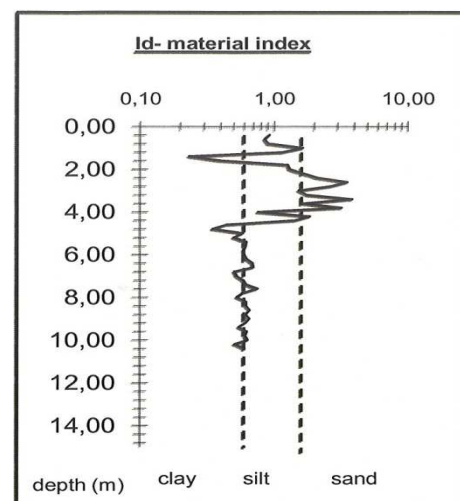
Fig. 1. I_D (DMT1).

Based on the geological investigations and data map, the upper layer consists out of a sandy silt (quaternary deposit). Under this layer the tertiary overconsolidated Boom Clay can be found. This can be seen also on the I_D -diagram as presented below.

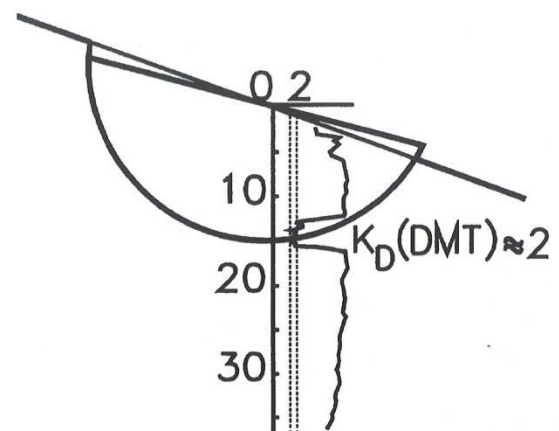
Fig. 4. Principle of the DMT- K_D -method

The principle of the DMT- K_D -method for the detection of slip surfaces can be shown as follows. (Marchetti, 1997).

In many OC clay landslides, the sequence of sliding, remoulding and reconsolidation, leaves the clay in the slip zone in a normally consolidated (NC) or nearly NC state, with loss of structure, ageing or cementation effects.

In genuinely NC clays (no structure, ageing or cementation) the horizontal stress index K_D from the DMT is approximately equal to 2, while K_D values in OC clays are considerably higher (for the Boom Clay about 8).

Therefore it is known that, if an OC clay slope contains clay layers with $K_D \approx 2$, these layers are highly likely to be part of a slip surface (active or quiescent).

The DMT- K_D -method method consists on identifying zones of NC-clay in a slope, using $K_D \approx 2$ as the identifier of the NC zones.

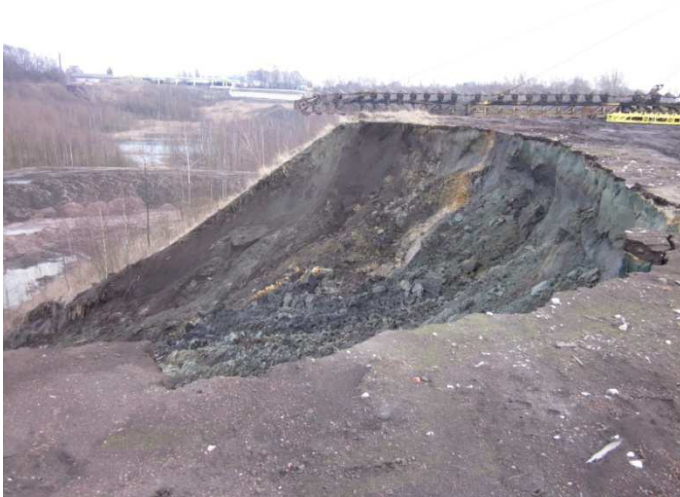
Fig. 6. Photo of the unstable zone after sliding

In the second half of 2013 a more important slide occurred in the neighborhood of point 5 on figure 2. The number 5 refers to DMT 5 executed in the beginning of 2014 at a distance of 5 m from the top of the slope.

In the figure 6 a photo of the slide is presented.

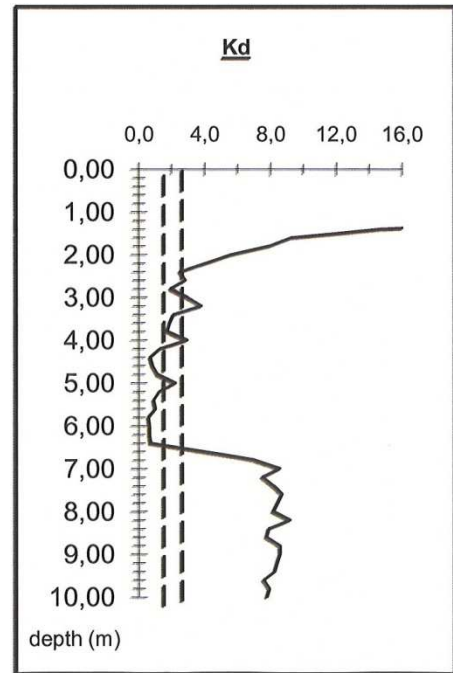
Fig. 7. K_D -profile for DMT 5

In the figure 7 the K_D -profile of DMT 5 is given (about 3 months after the sliding). The sliding occurred in the quaternary layer until a depth of about 1.5 m in the Boom Clay.

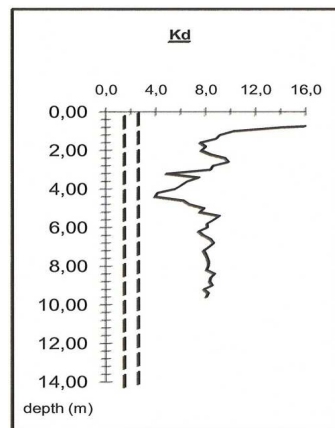
(a) (b)
Fig. 11 – K_D before (a) and after (b) sliding (DMT1/DMTE)

The results are presented in the figures 11 for DMT1/DMTE and 12 for DMT2/DMTA.

In the figures 11 and 12 one can clearly see the effect of the instability on the value of K_D in the upper quaternary layer and the top of the Boom Clay.

It is also important to notice that the K_D -values in the upper meters of the Boom Clay decrease from about 8 to 6.

The K_D -profile is presented on figure 16. Compared with figure 11, one can see that there is still a smaller value of K_D in the upper meters of the Boom Clay. The K_D -values in the more sandy layers seem to be increased after installation of the drain.

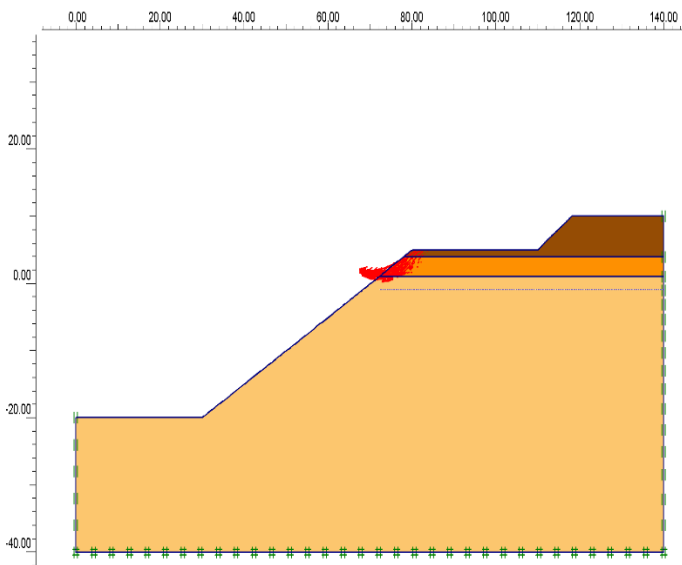
Fig. 13 – PLAXIS-analysis

Further investigation and additional calculations showed the importance of the groundwater pressures on the horizontal equilibrium.

Additional CPT-tests and laboratory tests were executed in order to make a detailed stability analysis. Based on an analytic and numerical analysis (PLAXIS-calculation) it was possible to prove clearly the cause of the instability and to design an appropriate improvement of the horizontal stability.

The figure 13 presents the calculated critical horizontal disequilibrium due to the presence of the groundwater.

The analysis resulted in a design where a deep drain has to be installed at a depth of 5 m., as shown in the figures 14 and 15. This drain was installed at the beginning of November 2015. The red line in figure 15 is the position of the drain in plan view.

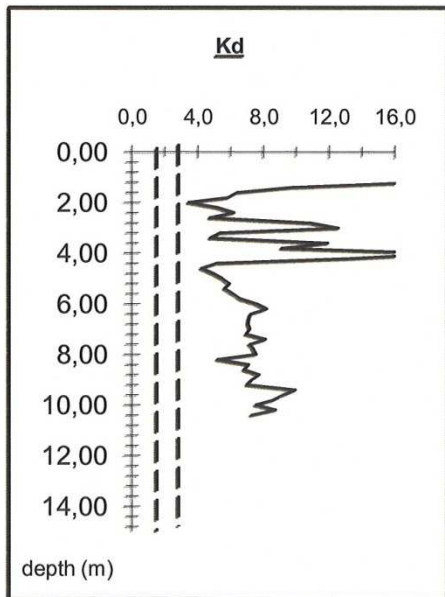
Fig. 16. K_D -profile after installation drain and remediation works

In January 2015 a first series of tests was carried out after the installation of the drain and the execution of works to smoothen the slope. Four tests were carried out. In this article only the result of DMTI (in the immediate neighborhood of DMT1 is presented).

Although the distance between DMT1 and DMTI is limited (about 2 m), for sure an improvement of the K_D -values could be expected. Further investigation,

in neighbor points and in the future, after definitive remediation of the slope, has to confirm this result.

The K_D -value in the upper more sandy overconsolidated layer, increased again but irregularly after the installation of a deep drainage.
