## Strain and crack development in continuous reinforced concrete slabs subjected to catenary action

Dirk Gouverneur<sup>a</sup>, Robby Caspeele<sup>\*</sup> and Luc Taerwe<sup>b</sup>

*Department of Structural Engineering, Ghent University, Technologiepark-Zwijnaarde 904,  
9052 Ghent, Belgium*

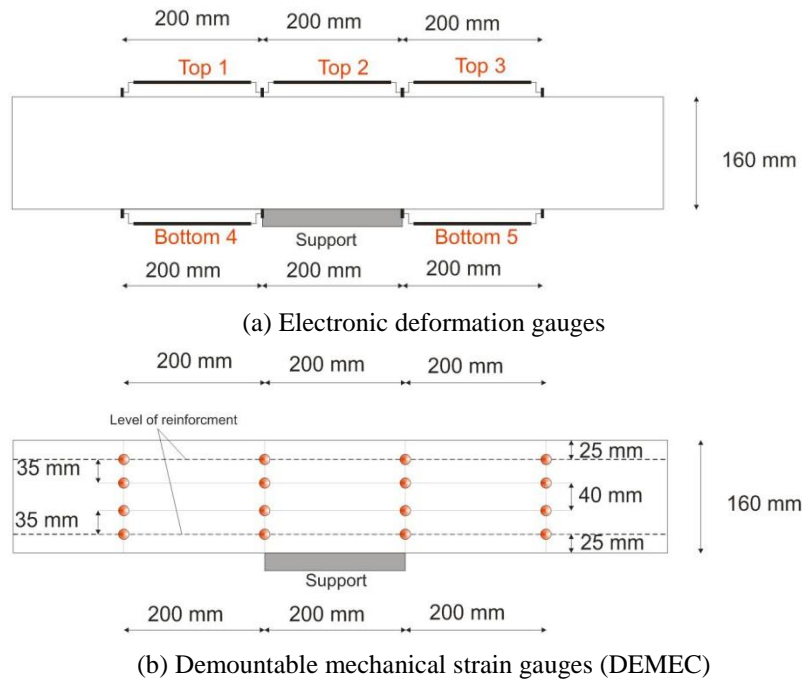
Fig. 5 Electronic and manual strain measuring devices at the supports

Multiple displacement transducers (LVDTs) and dial gauges were positioned at various points in order to record vertical and horizontal displacements. In addition, demountable mechanical strain gauges (DEMECs) and electronic deformation gauges were used to measure strains at mid-span (central support), under the loads as well as over the inner supports. Fig. 5 illustrates schematically the location of the electronic and manual strain measuring devices at the supports (side view).

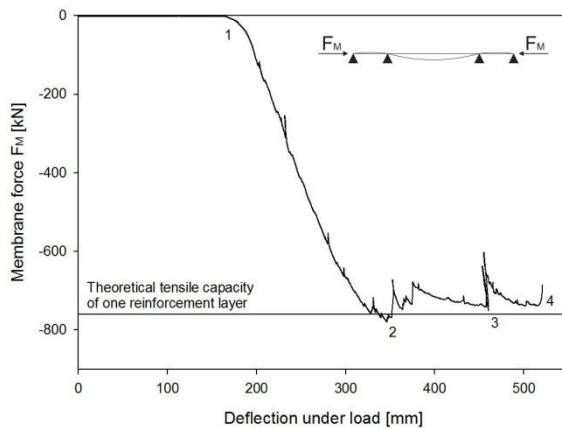
Fig. 9 Development of membrane force, Phase 3

Figs. 8 and 9 show the load-displacement behaviour of the specimen in phase 3 (Fig. 8) and the development of the tensile membrane force (Fig. 9). The line loads were applied displacement controlled. Tensile membrane actions started to act at a deflection of around 160 mm (point 1) as a result of the restraint of inward movement, thus enhancing significantly the load-carrying capacity of the specimen. The rupture of the top reinforcement bars over the left support (point 2) as well as over the right support (point 3) initiate a decrease in the slope of the load-displacement graph. The rupture of the bottom reinforcement over the right support at a deflection of 525 mm at the load application points (645 mm at mid-span) at a load level of 180 kN resulted in the failure of the specimen (point 4). Further, the theoretical elastic capacity corresponding to the moment  $M_y = A_s f_y h$  with  $A_s$  the cross sectional area of one reinforcement layer,  $f_y$  the yield strength of the reinforcement and  $h$  the lever arm (135 mm) is indicated in Fig. 8 as a horizontal line. A maximum horizontal tensile force of up to 780 kN was measured (see Fig. 9).

and the cross sectional area of one reinforcement layer  $A_s = 1257 \text{ mm}^2$ , the values  $A_s f_y = 697 \text{ kN}$  and  $A_s f_t = 760 \text{ kN}$  (see horizontal line in Fig. 9) are obtained (with  $f_y = 555 \text{ MPa}$  the yield strength and  $f_t = 605 \text{ MPa}$  the tensile strength) of the reinforcement obtained as the mean values from experimental results described in section 3.1.

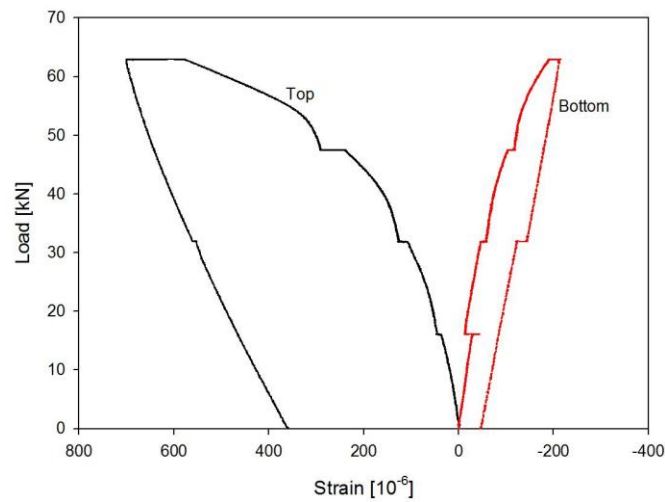
Fig. 10 Strain development measured by electronic deformation gauges (Fig. 5a) at the central support, Phase 1

The development of strains at the top and bottom fibres of the mid-span section is given in Fig. 10 (digital measurements) and the strain distribution over the slab depth in Fig. 11 (mechanical measurements).

During phase 1, the slab's top face was stretched due to the hogging moment over the central support (Fig. 10). Accordingly, the bottom face was subjected to compression. In Fig. 11 it can be noticed that strains increased gradually until the service load (60 kN) was reached. At this load, strains of  $550 \times 10^{-6}$  (tension) were observed, whereas the bottom face developed a maximum strain of  $-70 \times 10^{-6}$  (compression).

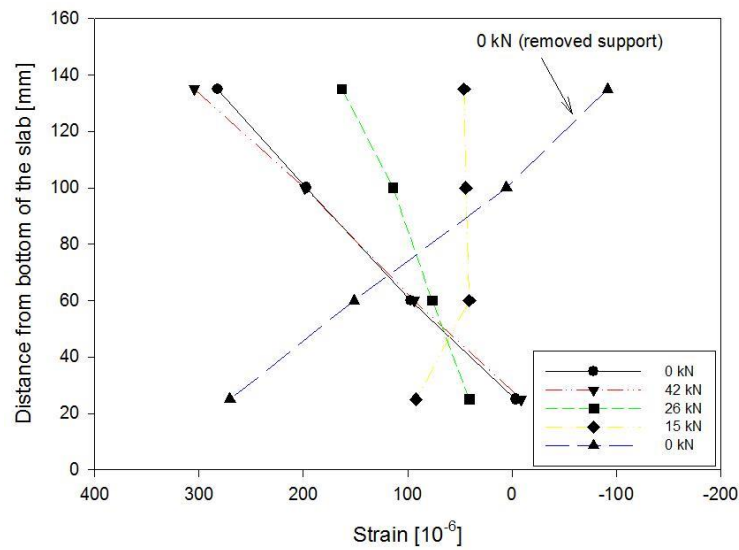
Fig. 13 Strain development measured by DEMECs (Fig. 5(b)) at the central support, Phase 2

Figs. 12 and 13 illustrate the strain development during phase 2 (removal of the central support).

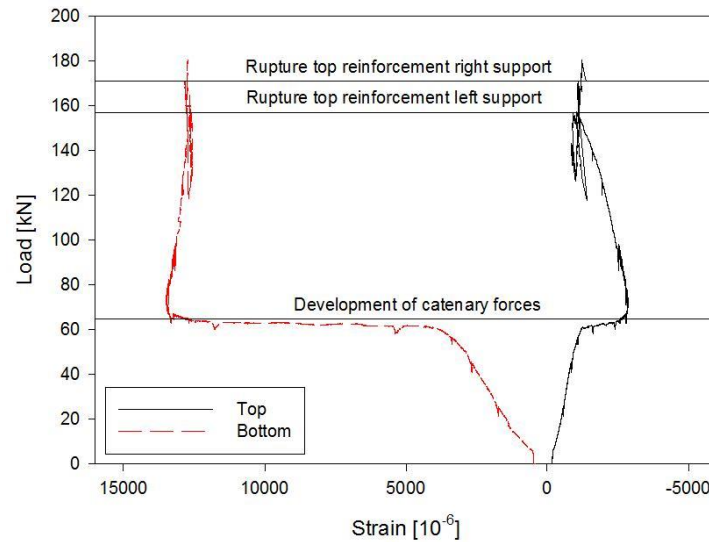
Fig. 14 Strain development (mean value) strain gauges, mid-span, Phase 3

Figs. 14 and 15 illustrate the strain behaviour during the third phase. Digital measurements were feasible until the collapse of the specimen. However, mechanical strain measurements could

Initially, the strain behaviour was observed to be linear (see Fig. 14). With further load application, however, yielding of the top reinforcement bars and subsequent development of plastic hinges occurred over the inner supports. Due to this behaviour, the outer edges of the slab strip tended to move inwards and the contact between the specimen and the restraining concrete blocks was established at a vertical load of around 62 kN. Tensile membrane behaviour forced the load-displacement curve to increase significantly (Fig. 8, path 1-2) and a catenary stage was introduced. Tensile strains at the bottom side of the specimen stayed at approximately the same level, whereas compressive strains at the top face of the specimen decreased. However, this tendency stopped at the rupture of the reinforcement as indicated in Fig. 14. At a load of 75 kN (Fig. 15), a strain of  $12.5 \times 10^{-3}$  was measured at the bottom side, whereas the top face developed a tensile strain of  $73 \times 10^{-6}$  at the measuring location.

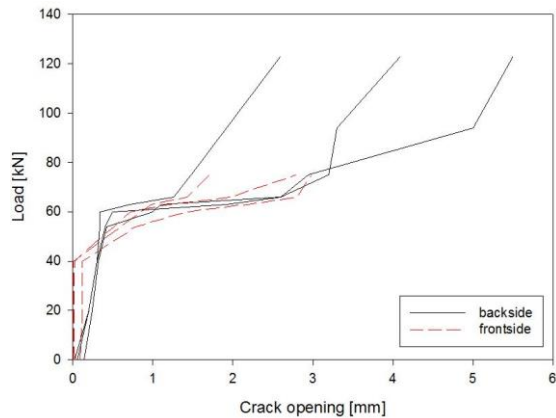
Fig. 21 Crack development left support, Phase 3

The crack development of the largest crack openings during phase 3 is illustrated in Figs. 21 (left support) and 22 (right support) until a load of 120kN. It was observed that all major flexural cracks persisted transverse to the longitudinal axis developing over the full width of the specimen. However, at stages of higher deformation of the inner supports, also horizontal cracks appeared at the level of the reinforcement (see pictures D in Figs. 18 and 20).

Measurements of crack widths were feasible until a displacement under the line loads of 200 mm on the frontside and 280 mm on the backside of the specimen. Both sides confirmed an increase in crack width after the formation of plastic hinges and subsequent development of tensile membrane forces. At a load of 123 kN the most severe cracks were measured to have an opening of around 5.5 mm.

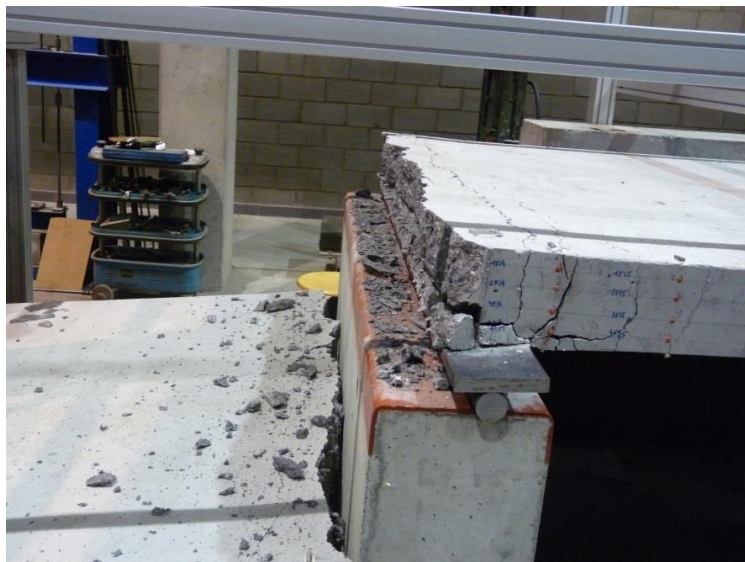
Fig. 23 Failure of the specimen due to complete rupture of the longitudinal reinforcement at the right inner support

Fig. 23 shows the right inner support after collapse, which was ultimately induced by the tensile failure of the reinforcement bars in a crack over one of the supports, where plastic hinges developed. Hence, the failure mechanism is predominantly related to bending in combination with the rupture of the steel reinforcement at high strain deformations, which was confirmed by the experimental observations after testing.
