Addressing the need for standardization of test methods for self-healing concrete: an inter-laboratory study on concrete with macrocapsules

Development and commercialization of self-healing concrete is hampered due to a lack of standardized test methods. Six inter-laboratory testing programs are being executed by the EU COST action SARCOS, each focusing on test methods for a specific self-healing technique. This paper reports on the comparison of tests for mortar and concrete specimens with polyurethane encapsulated in glass macrocapsules. First, the pre-cracking method was analysed: mortar specimens were cracked in a three-point bending test followed by an active crack width control technique to restrain the crack width up to a predefined value, while the concrete specimens were cracked in a three-point bending setup with a displacement-controlled loading system. Microscopic measurements showed that with the application of the active control technique almost all crack widths were within a narrow predefined range. Conversely, for the concrete specimens the variation on the crack width was higher. After pre-cracking, the self-healing effect was characterized via durability tests: t

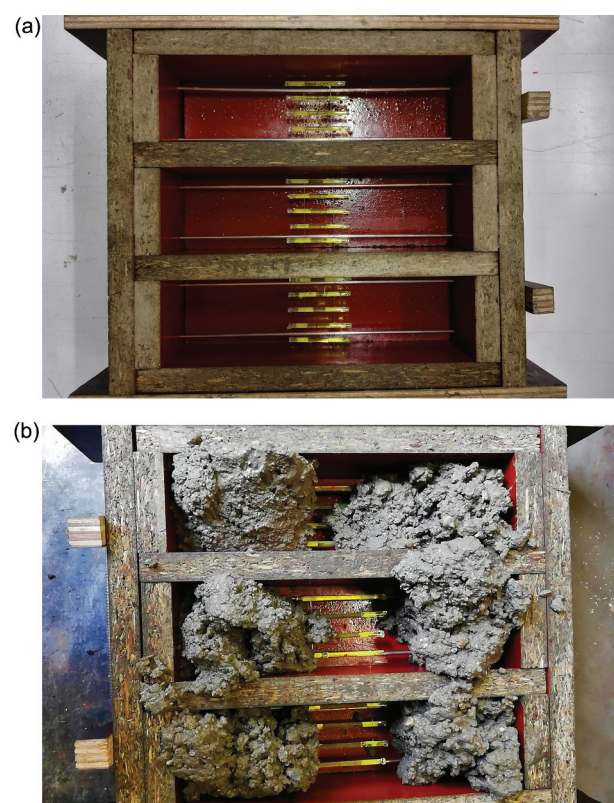
Figure 2. Moulds to make concrete specimens ($60 \times 60 \times 220 \text{ mm}^3$) with capsules (a: mould with five capsules; b: casting of specimens with four capsules).

agent to a slightly larger area of the crack in order to obtain perfect healing, see Figure 1 a. For the layout with five capsules, the requirement that the largest aggregates should be able to pass between the capsules and the side faces was not imposed as this would cause too much deviation from the identical circular outflow for the outermost capsules. Instead extra care was taken in filling and compacting these moulds. In both layouts, capsules were prepositioned in the moulds by gluing them on a nylon wire running just above the reinforcement, see Figure 2.

All specimens were compacted on a vibration table. For the specimens with capsules, concrete was first placed next to the capsules, see Figure 2. The vibration table was then activated allowing the concrete to flow under and between the capsules, after which the rest of the concrete was added. The specimens were stored in a curing room (20°C and >95% relative humidity RH) and the day after casting they were demoulded. No compaction defects were visible for the specimens with five capsules, despite the limited distance between the outer capsules and the walls of the mould. The specimens were sealed in plastic foil in groups of three to prepare them for shipping. Up until the moment of shipping the specimens remained in a climate room at 20°C.

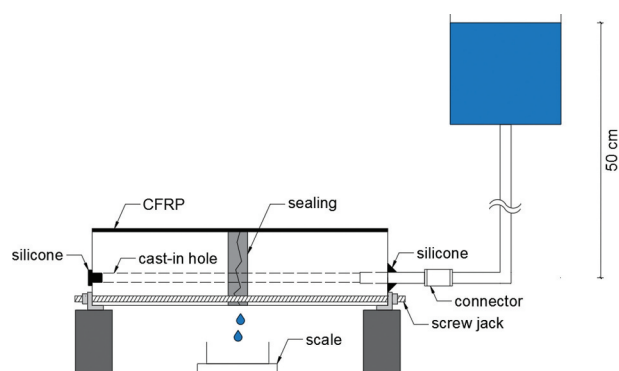
Figure 5. Water permeability measured by a constant head water flow test [33].

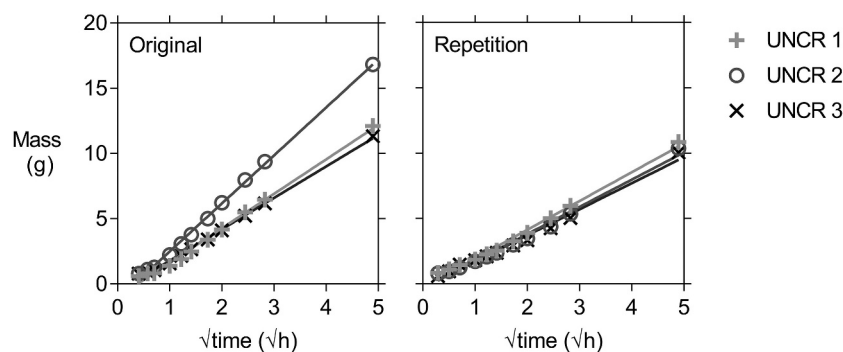
Figure 9. Comparison of the cumulative mass gain versus the square root of time for the uncracked specimens of lab 6 with the individual linear regression lines, showing a more uniform behaviour for the repeated waterproofing with aluminium tape compared to the original waterproofing with aluminium tape.

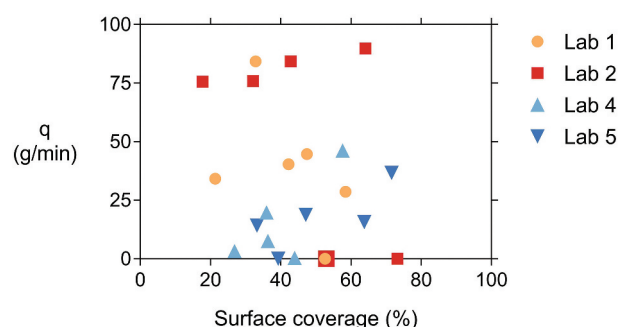
Figure 16. Water flow q versus the PU surface coverage for labs 1, 2, 4 and 5.

Figure 14. Figure 16 shows the water flow of the different specimens in function of their surface coverage. It is noted that it is impossible to obtain a perfect surface coverage since the area of the hole (used to induce the water in the permeability test) was taken into account in the total area. Anglani et al. [37] studied the same PU healing agent but encapsulated in one cementitious capsule with a larger diameter. These capsules had either an internal or an external epoxy coating to make them moisture-proof. They measured an average surface coverage of 36% for specimens with internally coated capsules and 47% for specimens with externally coated capsules. These values are comparable to the average surface coverage of the different labs, although it is noted that the variation is higher for the results reported here. The sealing efficiency measured by Anglani et al. [37], using the same permeability setup as is used in the current study, was equal to 79%, respectively 28%, for the specimens with an internally, respectively externally, coated capsule. Lab 1, 2, 4 and 5 obtained a sealing efficiency between 44% and 73% which falls in between these values.

From Figure 16 it could also be concluded that a high surface coverage does not directly translate into a good sealing efficiency. There seems to be no strong relationship between the surface coverage and the water flow. Indeed, the surface coverage only has an indirect influence on the water flow. Figure 17 shows a crack surface overlaid with its filtered segmented image determined using the Trainable Weka Segmentation plugin in ImageJ, see section 2.3.4. The surface coverage of this sample was one of the highest (71.6%), yet the zone below the hole was not completely covered with PU, leaving a path for the water to leak out of the specimen. To seal a crack, it is sufficient if the crack mouth is filled with healing agent, or in the studied specimens if the water-inducing hole is surrounded with healing agent. For many specimens it was noted that the PU spread regions from the individual capsules did not connect, and thus a barrier to withstand the water pressure could not be created.

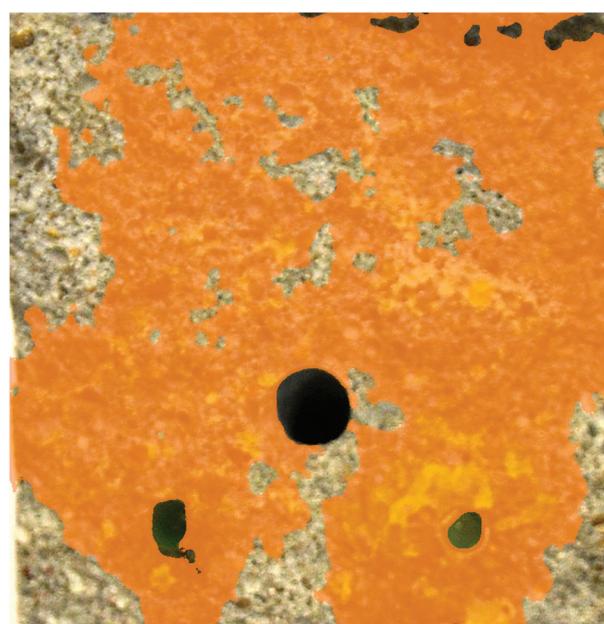
Figure 17. Crack surface ($40 \times 40 \text{ mm}^2$) of one of the specimens with the best PU surface coverage but still a significant flow due to an unconnected crack filling below the cast-in hole (through which water was induced during the permeability test). The crack mouth through which water leaked out of the specimen is oriented to the bottom, like in the water flow test.

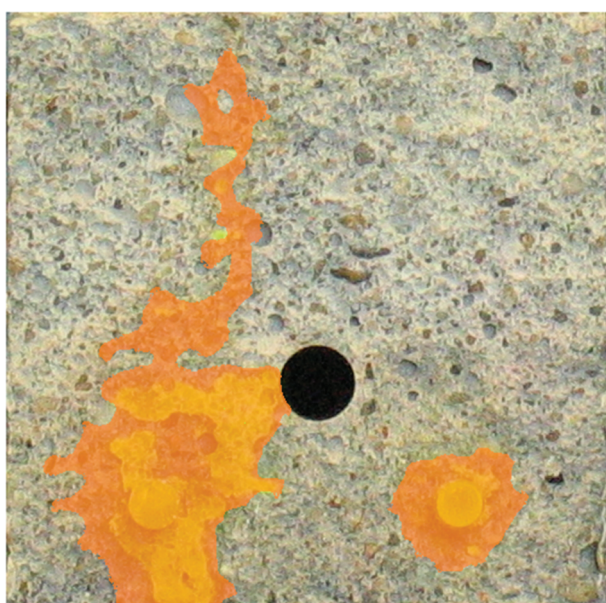
Figure 18. Crack surface ($40 \times 40 \text{ mm}^2$) of specimen with limited PU surface coverage. The crack mouth through which water leaked out of the specimen is oriented to the bottom, like in the water flow test.
