Article

Examining the Potential of Enzyme-Based Detergents to Remove Biofouling from Limestone Heritage

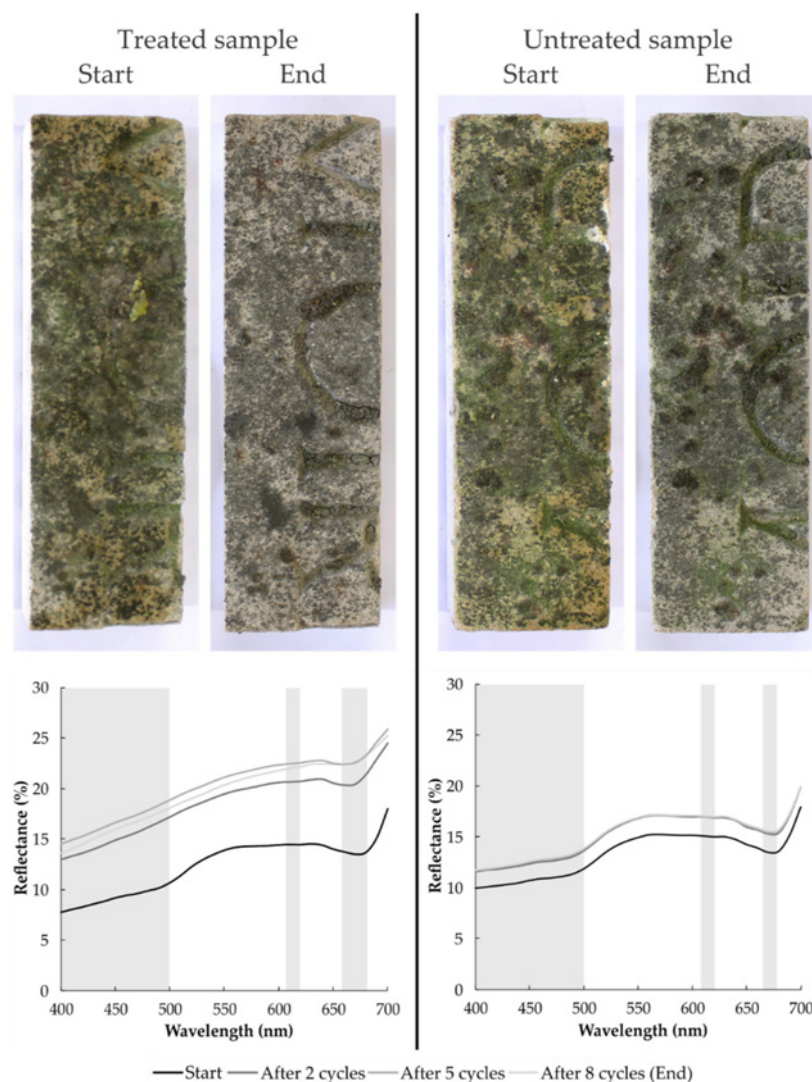
Figure 3. Appearance of a representative treated (Sample 2) and untreated (Sample 8) biofouled stone at the start and end of the experiment and spectral reflectance graphs showing the evolution of the spectra over time. The areas of chlorophyll absorption are indicated in grey.

All samples were severely colonised, which affected the aesthetic appearance of the stones. The effect of the enzyme-based treatment on Portland limestone is illustrated and compared with an untreated sample in Figure 3. There was a lower reflectance for small wavelengths, and the biological pigments caused the typical local minima in the spectral reflectance graphs between 400 and 500 nm and around 670 nm, as well as some more subtle minima, such as the one around 610 nm.

The enzyme-based treatment was effective, as in the treated sample, the reflectance increased. Moreover, the local spectral reflectance minima linked to biological pigments became obscure or disappeared, suggesting a decrease in biocolonisation. The local minima between 400 and 500 nm smoothed rapidly after a few cycles, whereas the one around 670 nm smoothed more gradually. The untreated samples also reflected more light, although the spectral reflectance graphs remained similar throughout the whole experiment. Furthermore, the treatment caused the local minimum at 670 nm to shift to 660 or 650 nm, whereas it remained at 670 nm for the untreated samples.

Changes were also visible and captured with photography, but these were subtler and more gradual (Figure 3). Initially, all samples had a bright green appearance, but they turned dull after treatment. The untreated samples also lost some of their green pigmentation, but this was probably caused by the indoor conditions between the wetting phases. Similar observations were made on the other samples and Savonnières limestone.

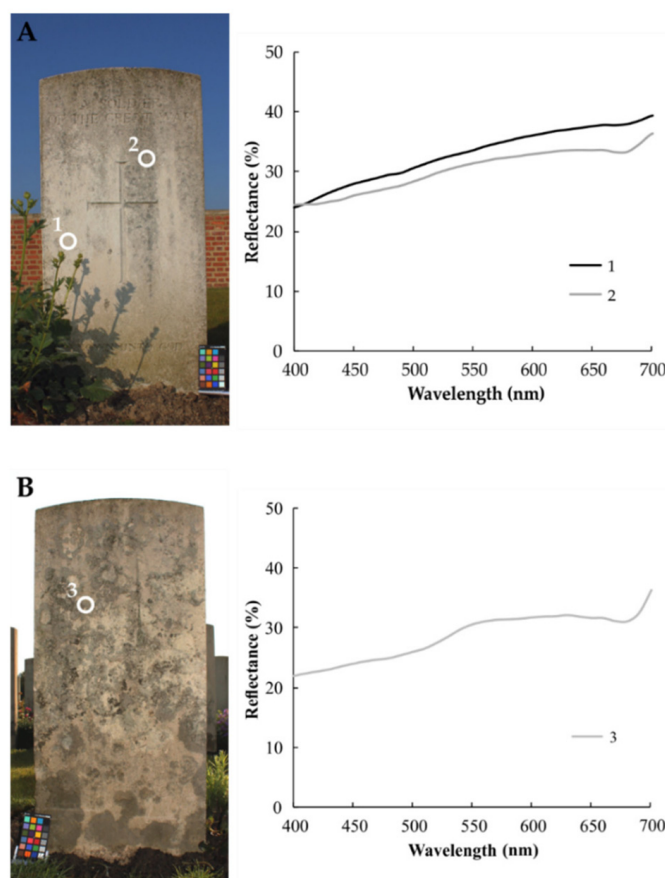
Figure 4. Spectral reflectance graphs retrieved before treatment from (A) a relatively clean and (B) an intensely biofouled headstone.

Figure 4 gives an example of spectral data measured on three spots of two biofouled headstones. On the first one (Figure 4A), grey to black biofilms were present running down from the horizontal top surface, whereas on the second one (Figure 4B), the headstone was mainly colonised by crustose lichens. Measurement 1 was taken in a relatively clean part of the stone, resulting in a relatively smooth spectral reflectance, with lower reflectance for shorter wavelengths. Measurement 2 was taken on the grey to black biofilm and showed absorption with a local minimum around 650–670 nm and a slight absorption in the 400–500 nm range related to biological pigments. Similar observations were made on the back with measurement 3, displaying even more intense absorption. The resulting chlorophyll discolouration of VIS 1, 2 and 3 was 1.73, 2.99 and 5.05, respectively.

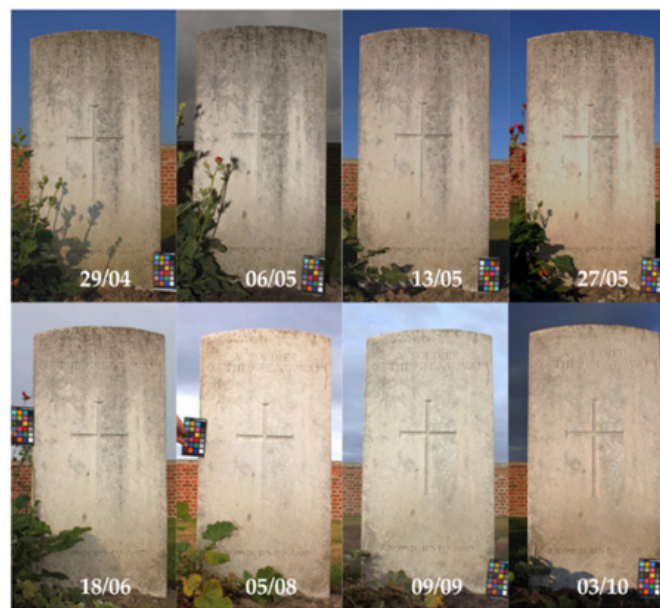
Figure 6. Evolution of grey-black biofilm in streaks (Site A).

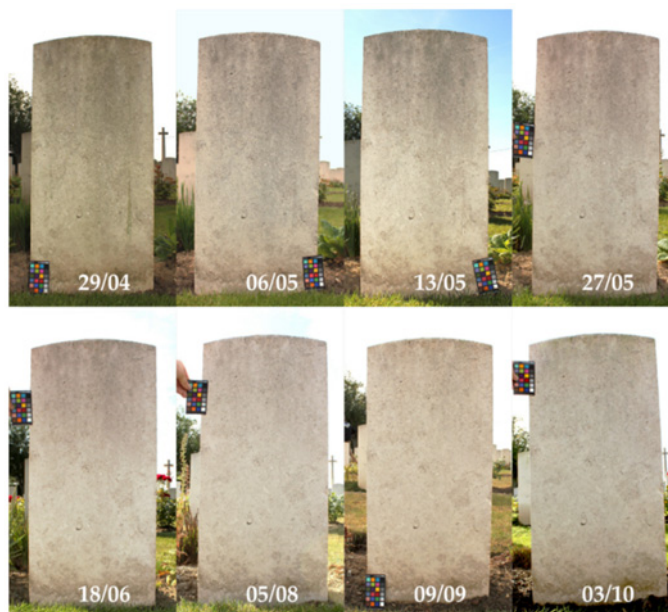
Figure 7. Evolution of grey-black biofilm in streaks and green biofilm (Site B).
