MACRO-MECHANICAL AND MICROSCOPIC STUDY OF THE FATIGUE DAMAGE BEHAVIOUR OF A CARBON FABRIC/PPS THERMOPLASTIC COMPOSITE

IVES DE BAERE, LINSEY LAPEIRE, WIM VAN PAEPEGEM, SUBAREDDY DAGGUMATI, KIM VERBEKEN AND JORIS DEGRIECK.

Department of Materials Science and Engineering, Faculty of Engineering, Ghent University. Technologiepark-Zwijnaarde 903, B-9052 Zwijnaarde, Belgium.

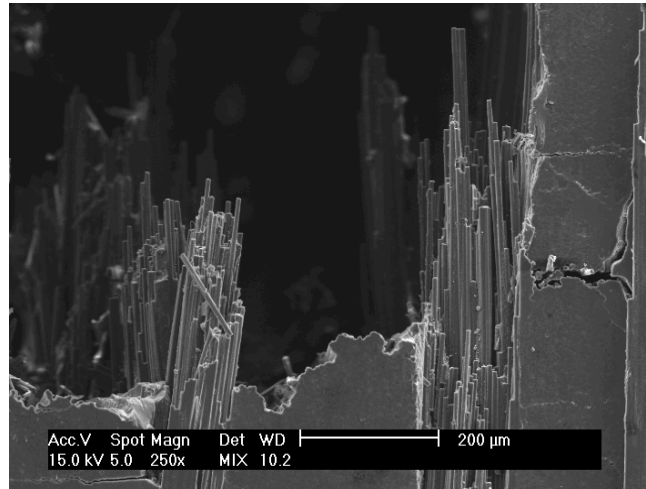
With respect to microscopic damage, Figure 3 shows a detailed SEM image of broken fibres of the fracture surface. Besides the fact that the carbon fibres show a brittle failure, it can clearly be noticed that in the fracture area, virtually no PPS is left on the fibres. The authors assume that the PPS is removed from the fibres due to friction of the fibre in the matrix.

Figure 3   SEM of broken fibres on the fracture surface of the [(0°,90°)]$_{4s}$ specimen with a magnification of 250x.

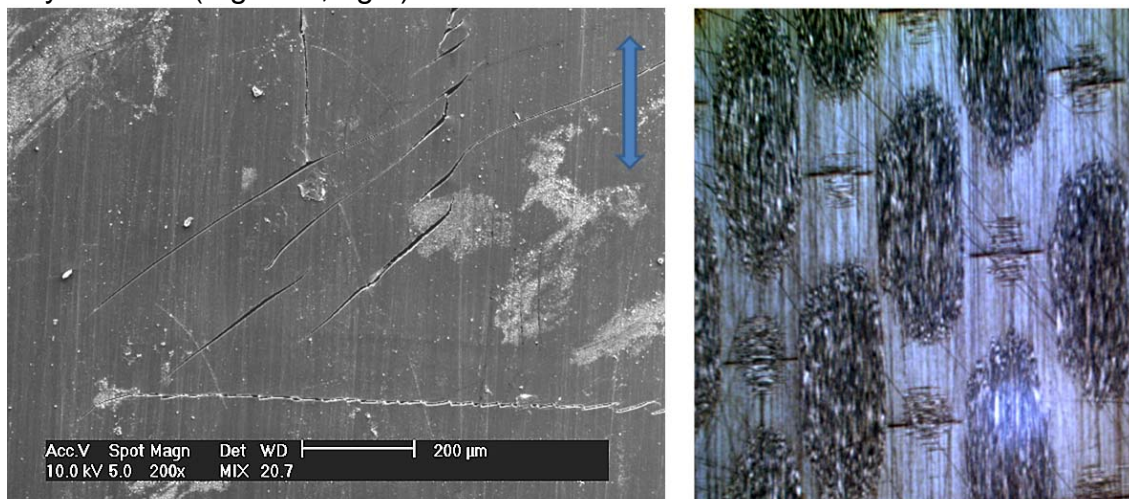
Figure 4 illustrates the top surface of a [(0°,90°)]$_{4s}$ specimen with both SEM and optical microscopy; this crack pattern was visible over the entire specimen. For the SEM (Figure 4, left), typical 45° cracks were observed in the area where there is a crossing over of the warp and weft bundles. The cracks in the weft bundles can also clearly be seen (Figure 4, right).

Figure 4   SEM of the top surface of the [(0°,90°)]$_{4s}$ specimen with a magnification of 200x (left) and optical microscopy with a magnification of 10x (right).

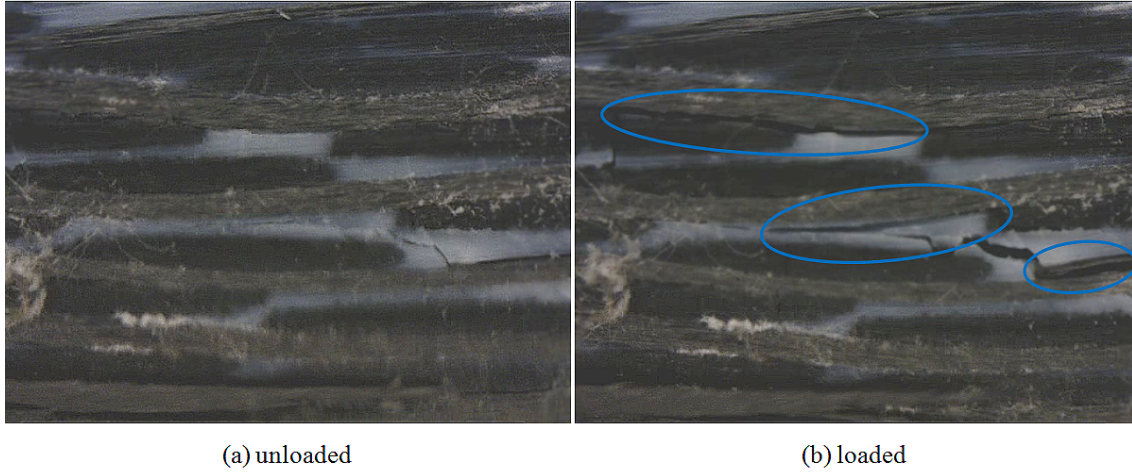
(a) unloaded   (b) loaded

Finally, Figure 5 shows pictures of the polished side of the specimen both unloaded (a) and loaded till 650 MPa (b) taken after 680 000 cycles. It can clearly be seen that significant meta-delaminations exist. What could also be observed during the test was that the warp fibre bundles moved freely in the layers, meaning that these bundles are completely debonded from the PPS matrix.

Figure 5   Illustration of the side of the specimen in both unloaded and loaded (650 MPa) state of a 650MPa@2Hz fatigue test, afters 680 000 cycles.

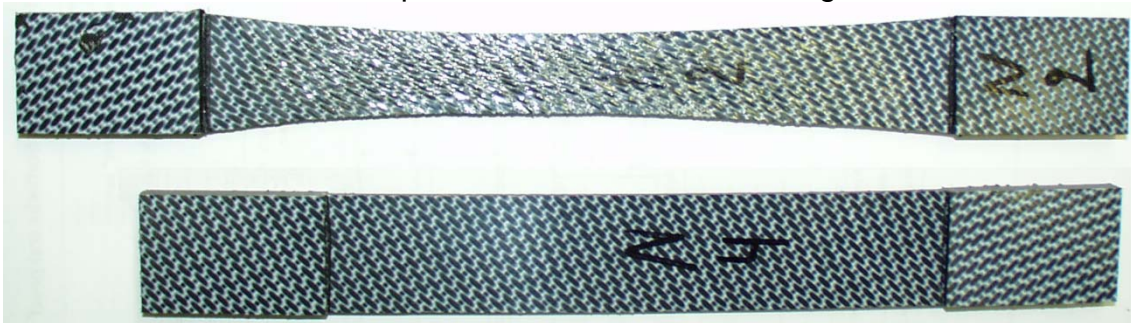
Figure 7   Deformed (top) and undeformed (bottom) [(+45°,-45°)]$_{4s}$ specimen.

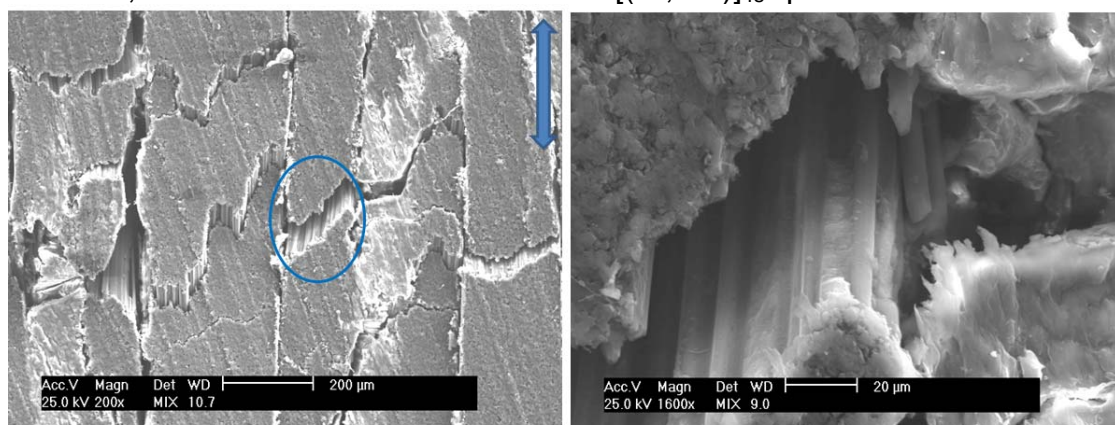
To determine the damage in the specimen, scanning electron microscopy was used on a similar sample, on which the test was stopped when the 'end-of-life' phase was reached. A sample was cut out of the necked area and both the top and the side surface where investigated. Figure 8 illustrates the side of the specimen and as clearly visible, a lot of damage is present. Not only a significant amount of splitting of the fibre bundles occurs, but almost every layer has delaminated. When observing the close-up (Figure 8, right), it can be noticed that there is almost no PPS attached to the fibres, similar to the fracture area of the [(0°,90°)]$_{4s}$ specimens.

Figure 8   SEM on the side of the [(+45°,-45°)]$_{4s}$ specimen with a magnification of 200x left and 1600x right.

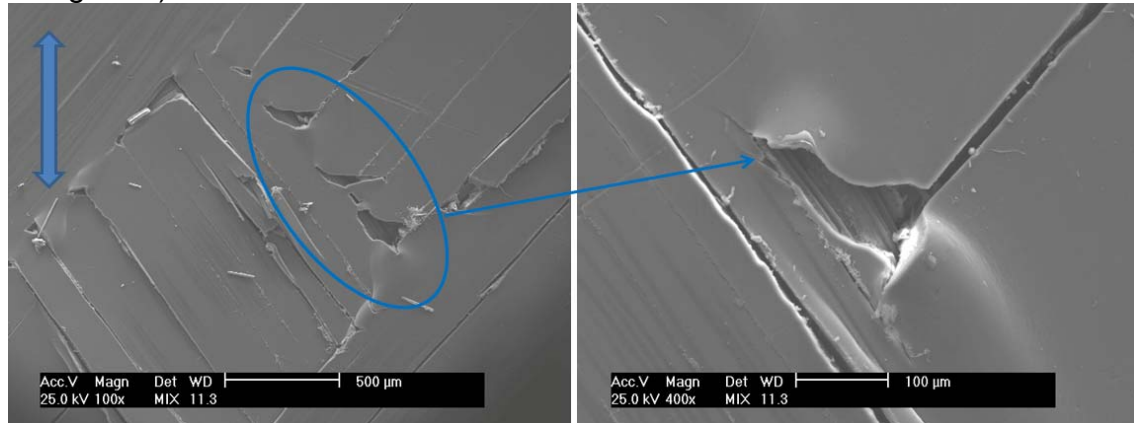
Figure 9 illustrates the top side of the specimen and this type of damage occurs over the entire specimen. Again, the splitting of the fibre bundles can clearly be seen, but also, triangular gaps can be found where the bundles cross over each other and a stress concentration is present. Similar cracks were found for the $[(0°,90°)]_{4s}$ tests (see Figure 4).

Figure 9   SEM on the topside of the $[(+45°,-45°)]_{4s}$ specimen with a magnification of 100x left and 400x right, illustrating the stress concentration at the bundle cross-over.
