High-density interconnect technology assessment of printed circuit boards for space applications

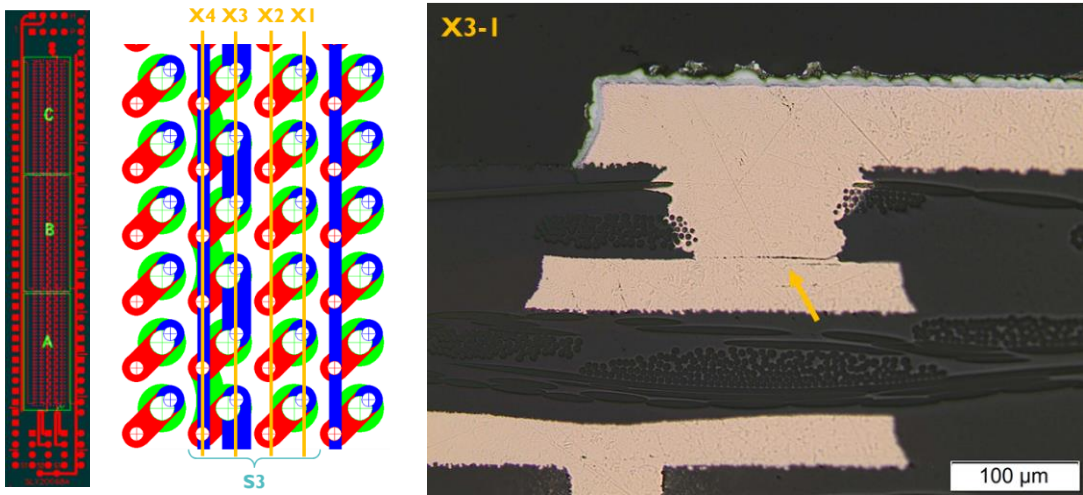
Two out of the three coupons for microvia testing reach the required 400 cycles. Testing of these coupons was stopped after 500 cycles to 210 °C. Coupon SLX3B failed after 285 cycles and does not reach the required endurance. As the failure could not be located using thermal imaging, failure analysis is performed by microsectioning the entire coupon row by row. Optical inspection revealed cracks near the target pad of microvia 1-2 (Figure 4). These cracks are observed on two microvias in the central zone of the coupon. The other microvia levels in this zone did not show any cracks. In other areas of the coupon, no cracks were detected on any of the microvia levels. Microvia 1-2 in the SLX coupon is located partially above the buried via (0.8 mm pitch fanout configuration). The thermal expansion as a result of the temperature excursions create stress at the base of the microvia. This effect is aggravated by the presence of the resin-filled buried via below. If the microvias in coupon SLX3B is slightly misaligned and thus overlaps more with the buried via compared to the other panels, this could explain the early failure.

Figure 4 - Crack found at the base of the microvia after microsectioing of coupon SLX3B

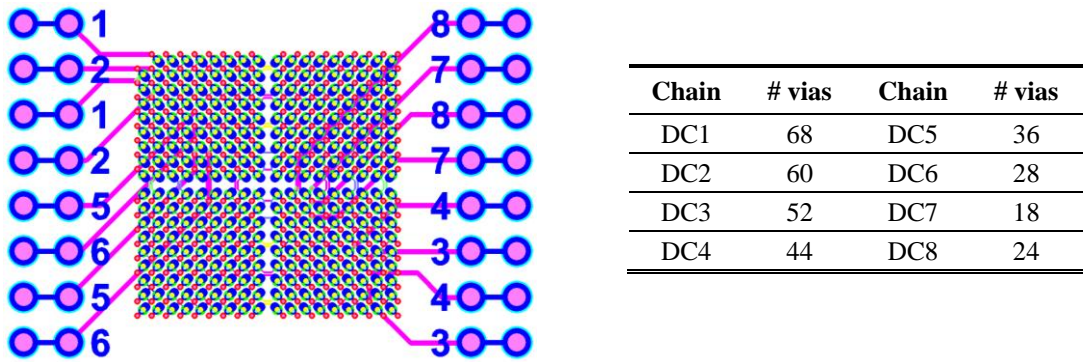
Figure 5 - Layout and number of vias of the daisy chains in the 0.8 mm pitch fanout

Figure 5 shows the details of the daisy chains in the 0.8 mm pitch fanout used for electrical monitoring. DC1 connects all the vias in the outer row of the component fanout, DC2 connects all the vias in the second row, and so on. Only the buried vias are included in the daisy chains and the number of buried vias per chain is indicated in the table on the right.

Chain	# vias	Chain	# vias
DC1	68	DC5	36
DC2	60	DC6	28
DC3	52	DC7	18
DC4	44	DC8	24

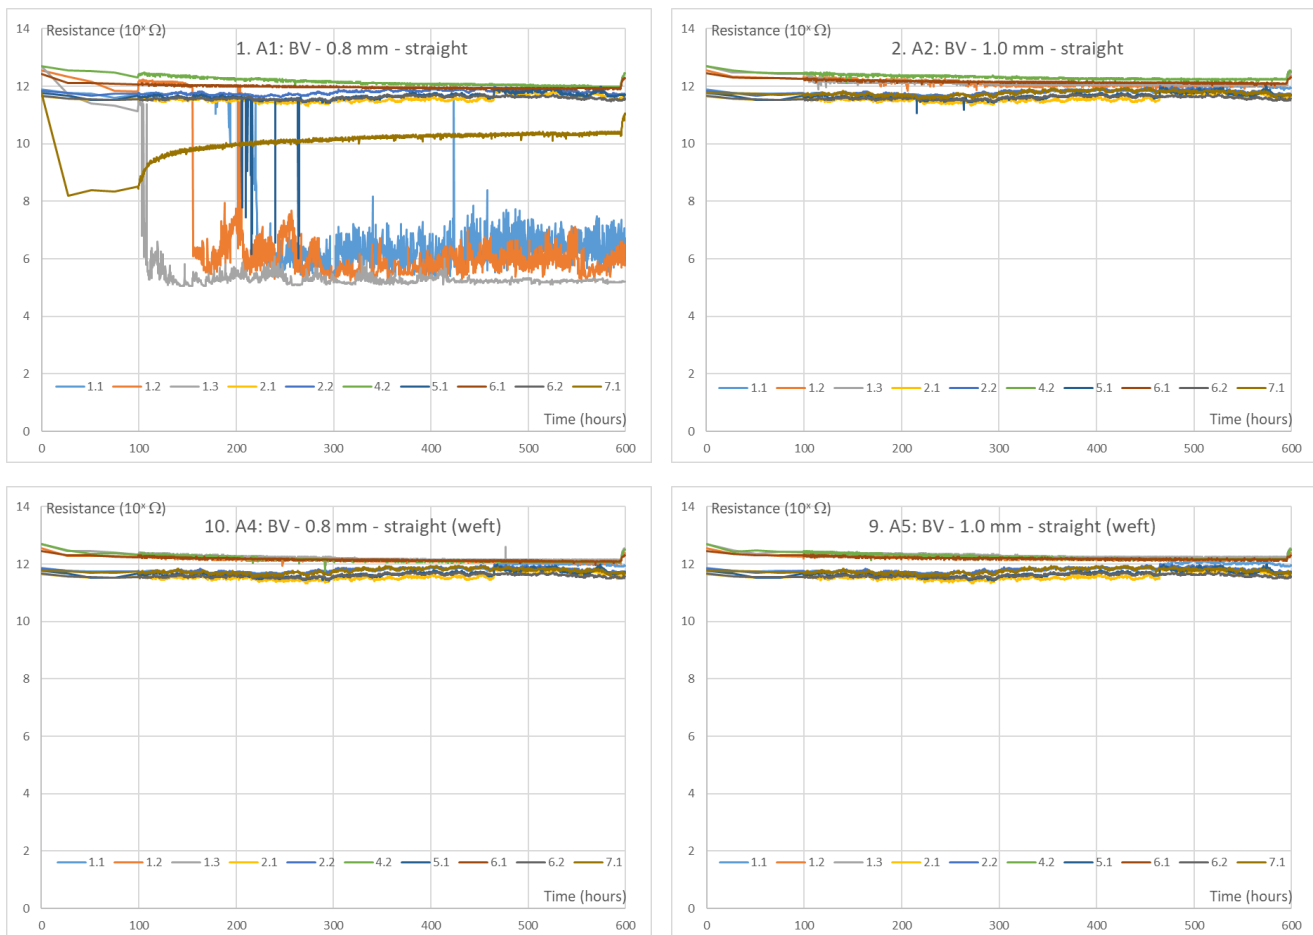
A detailed overview of the HDI CAF test results and associated failure analysis will be published elsewhere. As an example, Figure 6 shows the results for buried vias in a straight configuration with a pitch of 0.8 mm and 1.0 mm for both the warp and weft direction of the glass fibers. Figure 7 shows the results for the microvia test structure.

The failure criteria is a drop in resistance of more than one decade compared to the baseline resistance after 96 hours of soaking. No failures are observed between microvias at 0.5 mm pitch, buried vias at 1.0 mm pitch or PTHs at 1.27 mm pitch. Some failures occur between buried vias at 0.8 mm pitch. Most failures are detected in the via-to-plane test structures, especially for the PTHs. There is no significant difference between the antipad diameter for basic and complex HDI (75 µm vs 50 µm spacing). The exact nature of these failures is not yet known at the time of writing of this paper and failure analysis is ongoing.

Figure 6 – CAF test results for buried vias in a straight configuration with a pitch of 0.8 mm *(left)* **and 1.0 mm** *(right)* **for both the warp** *(upper row)* **and weft direction** *(bottom row)* **of the glass fibers**

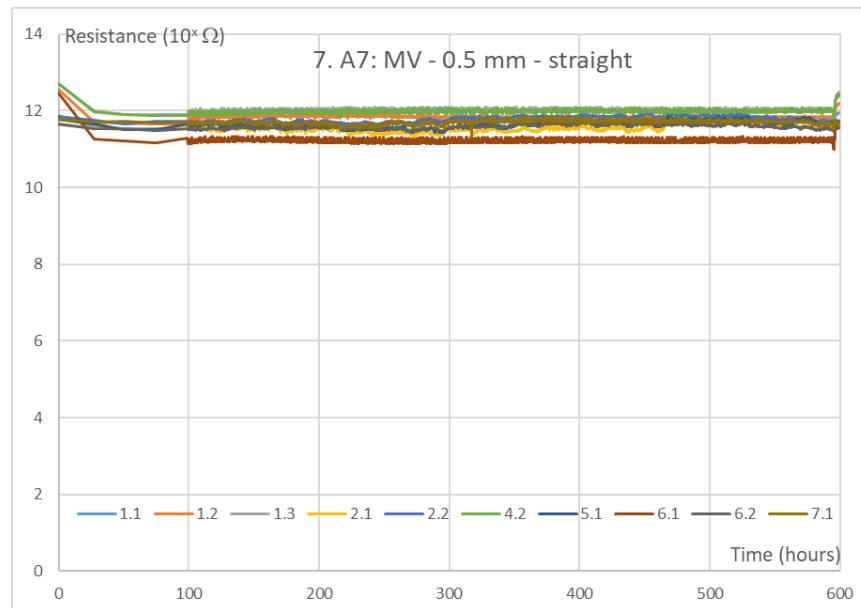
Figure 7 – CAF test results for microvias in a straight configuration with a pitch of 0.5 mm
