# A comparative analysis of the stability of a slope in an overconsolidated clay pit based on CPT and DMT measurements

# H. Peiffer

Laboratory of Geotechnics, Department of Civil Engineering, Ghent University, Ghent, Belgium

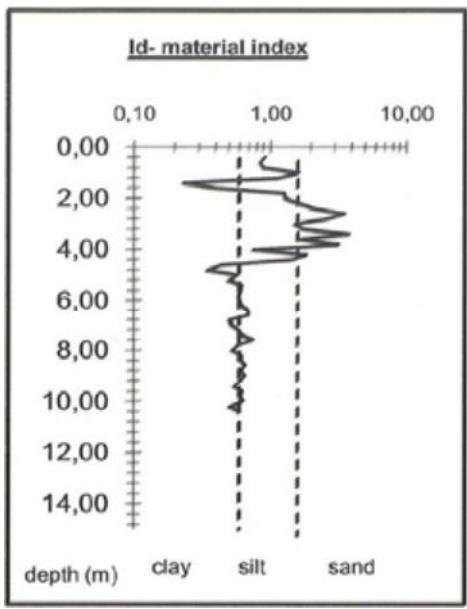
Figure 1.  $\overline{I_D(DMT1)}$

Based on the geological investigations and data maps, the upper layer consists out of a sandy silt (quaternary deposit). Under this layer the tertiary overconsolidated Boom Clay can be found. This can be seen also on the  $I_D$ -diagram as presented below. The profile confirms the results of the undisturbed sampling of the soil.

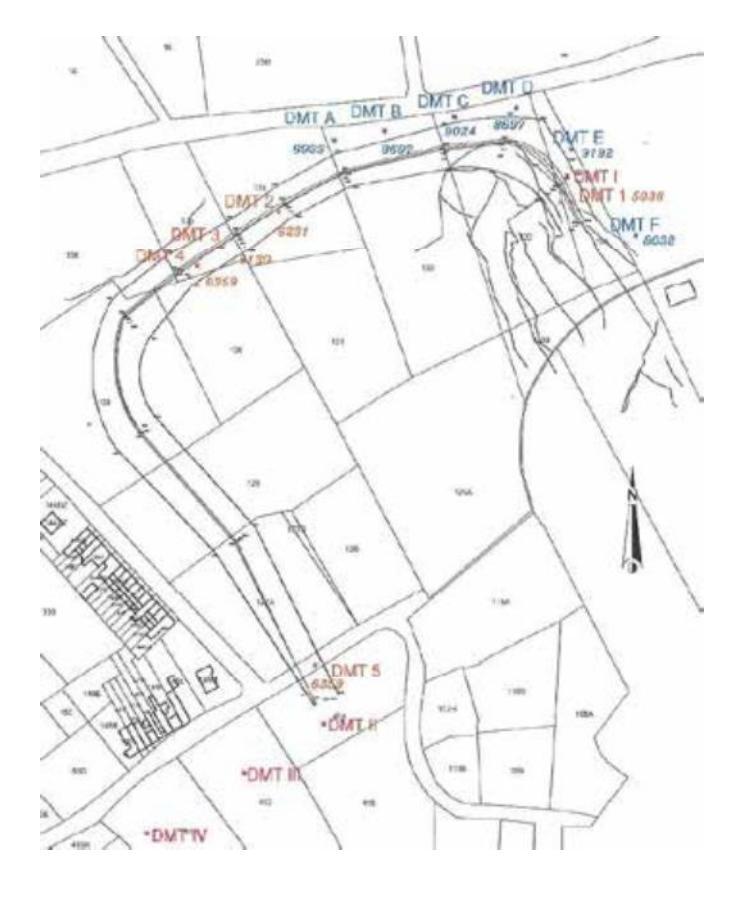
Figure 5. Overview in-situ tests

An overview of the monitoring points is presented in figure 5.

Until now four campaigns were organized :

January 2014 – DMT 1 to 5 (before the important sliding)

July 2014 – DMTA to F (about 1 month after the sliding)

January 2015 – DMT I to IV (after stabilizing) March 2016 - DMT1' to 5'

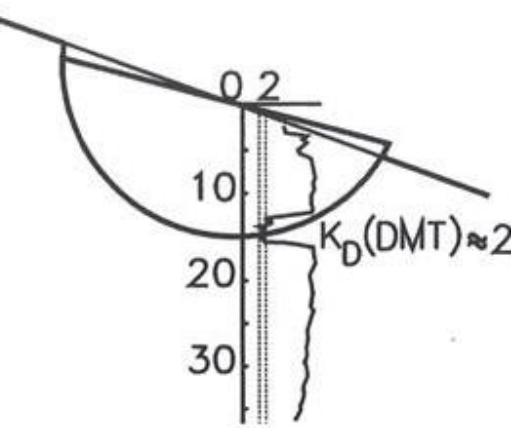
Figure 6. Principle of the DMT-K<sub>D</sub>-method

The principle of the DMT- $K_D$ -method for the detection of slip surfaces can be shown as follows. (Marchetti, 1997). In many OC clay landslides, the sequence of sliding, remoulding and reconsolidation, leaves the clay in the slip zone in a normally consolidated (NC) or nearly NC state, with loss of structure, ageing or cementation effects.

In genuinely NC clays (no structure, ageing or cementation) the horizontal stress index  $K_D$  from the DMT is approximately equal to 2, while KD values in OC clays are considerably higher (for the Boom Clay about 8).

Therefore it is known that, if and OC clay slope contains clay layers with  $KD \approx 2$ , these layers are highly likely to be part of a slip surface (active or quiescent).

The DMT-K<sub>D</sub>-method method consists on identifying zones of NC-clay in a slope, using KD  $\approx$  2 as the identifier of the NC zones.
