Performance of Time- and Frequency-Domain Analysis Techniques in Flash Thermographic Inspection of Monolithic and Sandwich Composite Parts

Gaétan POELMAN 1, Saeid HEDAYATRASA 1,2 and Mathias KERSEMANS 1 1 Mechanics of Materials and Structures (UGent-MMS), Department of Materials, Textiles and Chemical Engineering (MaTCh), Ghent University, Technologiepark-Zwijnaarde 46, 9052 Zwijnaarde, Belgium; Phone: +32 9 3310434, email: Gaetan.Poelman@UGent.be, Saeid.Hedayatrasa@UGent.be, Mathias.Kersemans@UGent.be 2 SIM Program M3 DETECT-IV, Technologiepark-Zwijnaarde 48, 9052 Zwijnaarde, Belgium; email: Saeid.Hedayatrasa@UGent.be

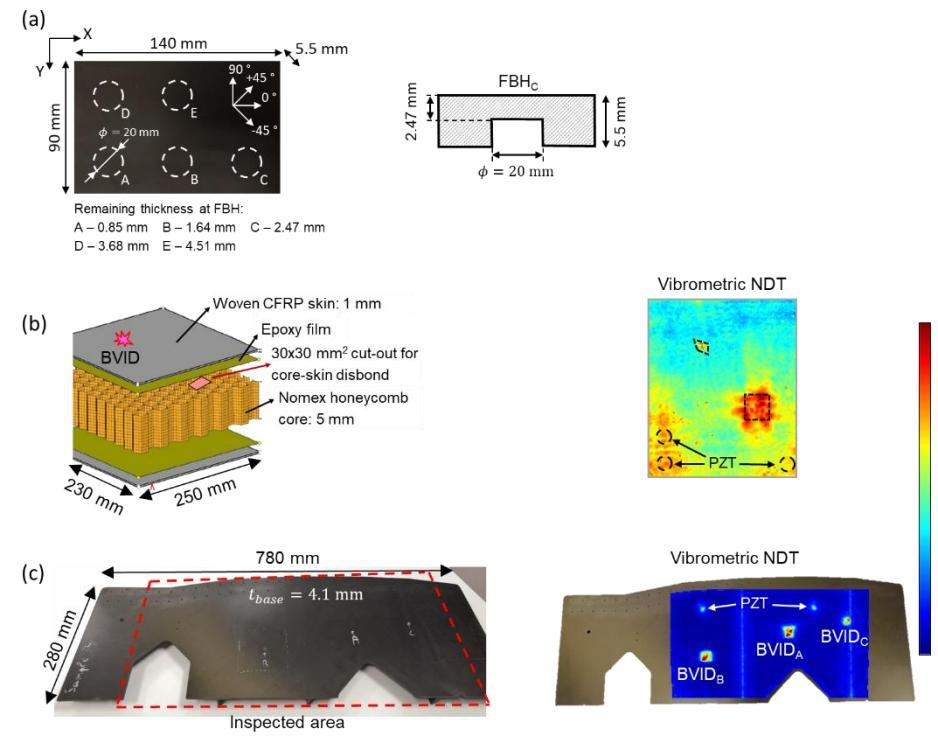
Figure 1: Inspected CFRP samples: (a) $CFRP_{FBH}$ with a schematic illustration of a flat bottom hole (FBH); (b) schematic illustration of $CFRP_{Sandw}$ and the result of a vibrometric NDT inspection; and (c) $CFRP_{Airbus}$ and the result of a vibrometric NDT inspection.

The first CFRP component, depicted in Figure 1(a), is a 5.5 mm thick cross-ply $[(-45/0/45/90)_3]_s$ sample with five flat bottom holes (FBH) of diameter 20 mm at different depths, and is called CFRP_{FBH} hereafter. Secondly, a sandwich part with woven CFRP skins and a Nomex honeycomb core is inspected (see Figure 1(b)). During production, a 30×30 mm² disbond was created between the skin and the core, while after curing, also a barely visible impact damage (BVID) was created on the same side. As a reference, the inspection result of vibrational testing is shown. The third inspected part is a component of the vertical stabilizer in an Airbus A320 (see Figure 1(c)), which has stiffeners at the back side. Three BVID damages were created by impacting the component with a 7.1 kg drop weight from three different drop heights (20 cm, 35 cm and 30 cm for BVID_A, BVID_B and BVID_C, respectively). The vibrational NDT inspection results are shown as a reference.

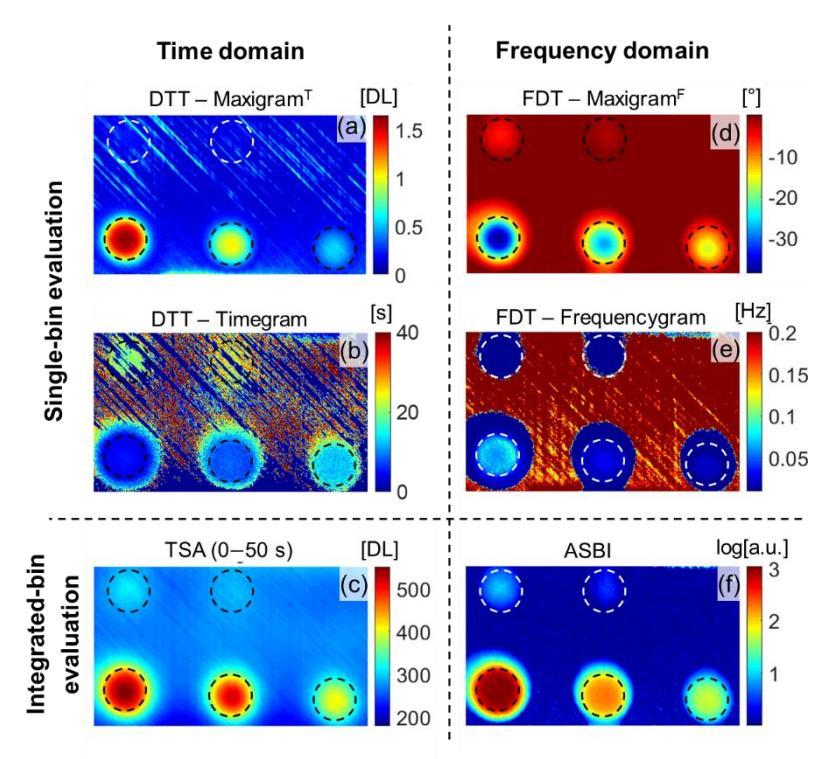
Figure 2: Processing results of the CFRP_{FBH} sample: (a,b) DTT maxigram^T and timegram; (c) TSA (0-50 s); (d,e) FDT maxigram^F and frequencygram; and (f) ASBI damage index map.

The results of the different post-processing techniques on the CFRP_{FBH} coupon sample are presented in Figure 2, with the true sizes and locations of the FBHs marked on the figures. Firstly, Figure 2(a,b) presents DTT's maxigram^T and timegram. In the maxigram^T, only the three shallowest FBHs (0.85 mm, 1.64 mm and 2.47 mm depth) are detected. Additionally, there are clear

effects of the fibre orientations which distort the background uniformity. The timegram in Figure 2(b) additionally hints the presence of the two deepest FBHs. The timegram is noisy since the values for sound pixels represent random fluctuations in the thermal contrast. Furthermore, the effect of lateral heat diffusion can be observed for the shallower defects, where the values in the timegram increase with the distance away from the FBH's centre. The defects therefore do not have a sharp outline in the timegram.

Several integration limits were carefully checked for TSA, and an integration over the first 50 s was found to provide a good detectability of the defects (see Figure 2(c)). This is a sensible integration range since it ranges over the timegram values of all FBHs (i.e. it encapsulates the times of maximum thermal contrast). In the TSA output, the three shallowest FBHs (0.85 mm, 1.64 mm and 2.47 mm depth) are clearly detected, while the presence of the fourth FBH (3.68 mm depth) is hinted. The background is significantly more uniform and less noisy than in DTT's maxigram^T and timegram. Of course, due to the integration procedure over a relatively long temporal range, the effects of lateral heat diffusion blur the edges of the shallow defects. In order to obtain better defect sizing, it would be beneficial to make the integration procedure adaptive in a pixel-wise manner. In that way, shallow defects will be associated with a shorter integration time which would limit lateral diffusion effects. Deep defects, on the other hand, will have longer integration times in order to increase their contrast.

The processed results of FDT are presented in Figure 2(d,e). The maxigram^F provides a good indication of the four shallowest FBHs (0.85 mm, 1.64 mm, 2.47 mm and 3.68 mm depth), and hints the presence of the deepest FBH (4.51 mm depth). Additionally, a highly uniform back-ground is retrieved, which provides a significant improvement over DTT's maxigram^T. The frequencygram provides an even better indication of the deepest FBHs, but with a noisier back-ground than the maxigram^F. Note that the frequencygram has the same values for the deepest defects due to the limited frequency resolution, which complicates the identification of their relative depth location. However, all defects have a very sharp outline in the frequencygram, as can be clearly observed in Figure 2 (e).

Lastly, ASBI's damage index map is shown in Figure 2 (f). It can be seen that all FBHs (depth up to 4.51 mm) are detectable with an almost uniform background and low noise level (note the logarithmic colour scale).

While DTT's maxigram^T and FDT's maxigram^F mainly serve for defect detection, DTT's timegram and FDT's frequencygram can be used for quantitative depth inversion. The main limitation for the timegram lies in its limited detectability of deep defects (FBHs detected clearly up to 2.47 mm depth, see Figure 2 (b)), however, quite uniform values are obtained over a defect's signature. On the other hand, the frequencygram can detect significantly deeper defects (detected up to 4.51 mm, see Figure 2 (e)), but the limited frequency resolution makes it practically very difficult to perform depth inversion for deep defects (deep defects have the same frequency values). With ASBI, only one single damage map is obtained, which serves for both defect detection and quantitative defect depth inversion (based on calibration curves from simulation) [8].

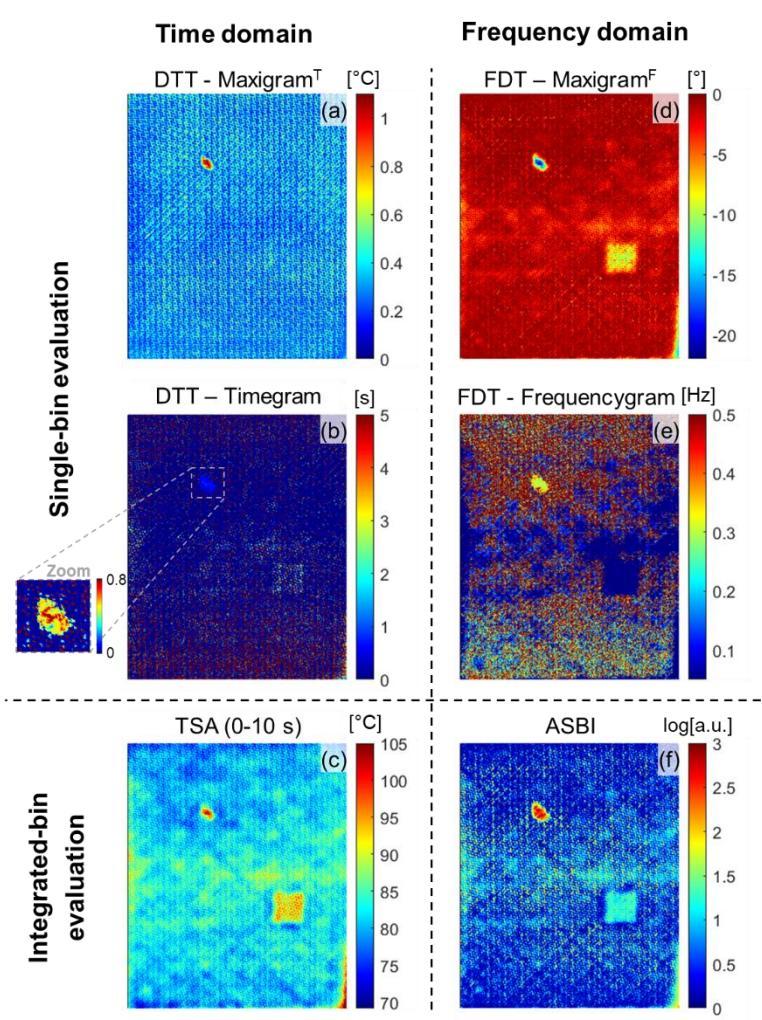
Figure 3: Processing results of the CFRP_{Sandw} sample: (a,b) DTT maxigram^T and timegram (with zoom of the BVID area); (c) TSA (0-10 s); (d,e) FDT maxigram^F and frequencygram; and (f) ASBI damage index map.

The post-processed results of the CFRP_{Sandw} sandwich part are displayed in Figure 3. With DTT's maxigram^T (Figure 3(a)), only the shallow BVID damage is detectable, while no trace of the skin-core disbond is observed. On the other hand, the woven structure of the CFRP skins is clearly visible in the result. In the timegram (Figure 3(b)), a hint of the disbond is observed, however, the background noise makes its detection non-trivial. The noise also covers a wide temporal range which appears to hide the BVID, however, a rescaling clearly indicates the BVID's presence (see inset). For TSA, it was found that integrating over the first 10 seconds after the flash excitation provided a good defect detectability of both the BVID and the skin-core disbond (see Figure 3(c)). TSA does not provide a uniform background, which is somewhat disturbing for defect detection. The disturbed region in the bottom right corner originates from lateral heat diffusion effects of the sample's clamping.

The maxigram^F obtained by applying FDT (Figure 3(d)) provides a very clear detection of both the impact damage and the disbonded region. The BVID and the disbond are both also identified in the frequencygram in Figure 3(e). As expected, a comparison of the dominant frequencies for both defects reveals that the disbond is located deeper than the BVID (defect depth is inversely proportional to the frequency of maximum phase contrast). Lastly, both defects are also straightforward to pinpoint in ASBI's damage index map (see Figure 3(f)). Besides providing a higher defect detection quality than TSA, ASBI additionally obtains a more uniform background than TSA.

The horizontal disturbance in the results are remnants of the non-uniform heating profile (linear flash bulb), which were not completely suppressed by temporal standardization (see Figure 3(c)) nor by phase calculations (see Figure 3(d-f)).

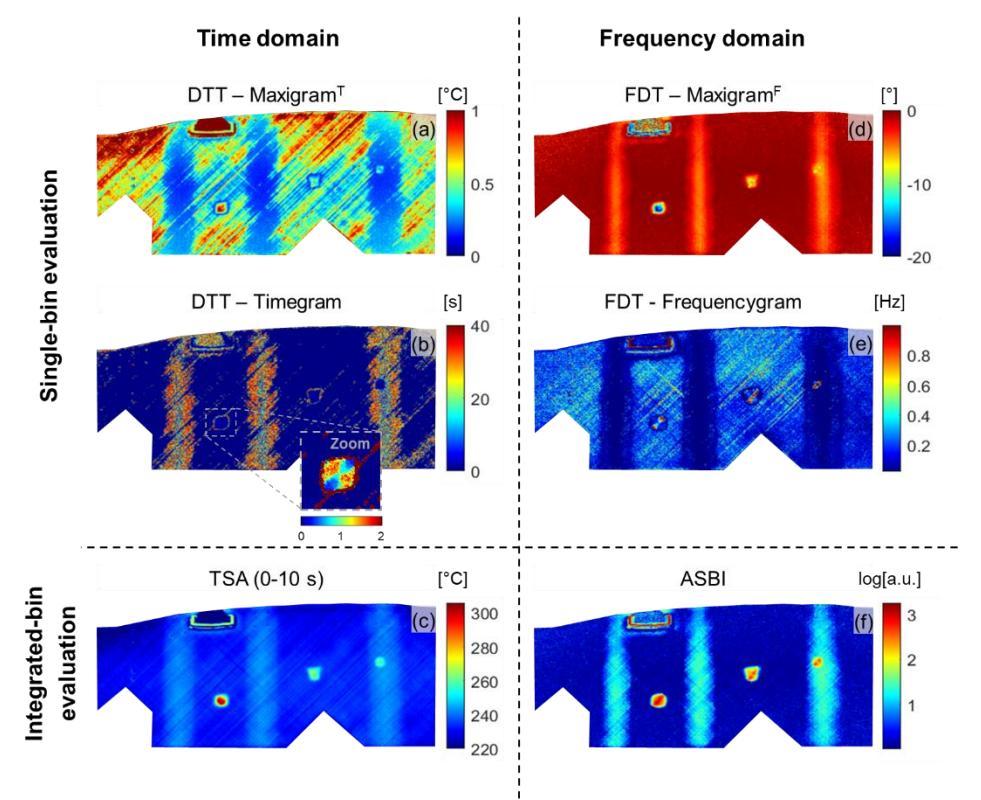
Figure 4: Processing results of the CFRP_{Airbus} sample: (a,b) DTT maxigram^T and timegram; (c) TSA (0-10 s); (d,e) FDT maxigram^F and frequencygram; and (f) ASBI damage index map.

The post-processed results of the Airbus A320 component with three BVIDs are presented in Figure 4. Notice that in each of the subpanels, the clamp that was used to hold the sample is located between the two stiffeners on the right. At first sight, the background obtained with DTT's maxigram^T is very noisy (see Figure 4(a)). The vertical stiffeners at the back side are observed as locations of reduced maximum thermal contrast (due to the increased material thickness). The three impact damages can be detected, however, the strong background non-uniformity is a disturbing factor. DTT's timegram (Figure 4(b)) provides a comparable detectability as the maxigram^T, but with a less pronounced background non-uniformity. In this case,

the stiffened regions are highlighted as areas of increased time values (i.e. later maximum thermal contrast) in comparison to the skin plate. It is interesting to observe that the two left BVIDs (which are not located on top of a stiffener), are surrounded by a thin border of higher time values (and lower maximum thermal contrast values, see the maxigram^T in Figure 4(a)), which indicates an increased depth and lateral extent of the BVID delaminations. The integration range corresponding to the first 10 seconds of cooling provided a good defect detectability with TSA (see Figure 4(c)). All three BVID's are easily detected as regions of increased value. Also the backside stiffeners are sharply indicated.

In frequency domain, FDT's maxigram^F is presented in Figure 4(d). The three BVID's, as well as the stiffeners, are easily found. Furthermore, a highly uniform background is obtained in the non-defected areas. The frequencygram in Figure 4(e) may also be used for the inspection of the features of this component, but suffers from a more pronounced background non-uniformity. Lastly, ASBI's damage index map (Figure 4(f)) provides a clear detectability of the defects, and in lesser extent of the stiffeners.
