The use of vacuum-assisted wound closure to enhance skin graft acceptance in a horse

M. Jordana, E. Pint, A. Martens

Department of Surgery and Anesthesiology of Domestic Animals, Faculty of Veterinary Medicine, Ghent University, Salisburylaan 133, 9820 Merelbeke, Belgium

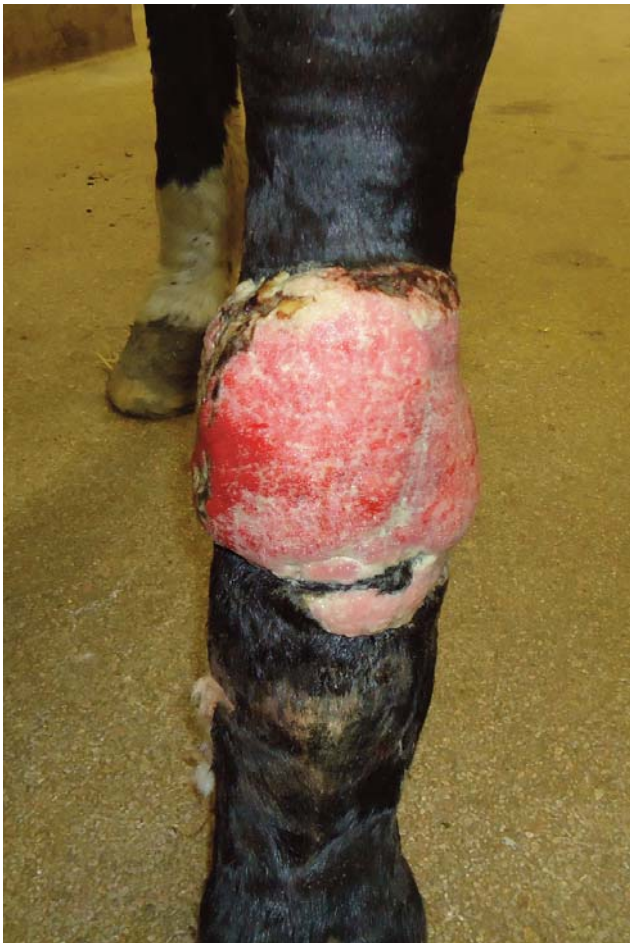
Figure 1. Appearance of the wound on the dorsomedial and dorsolateral aspects of the left metatarsus at the time of admission. Note the pale and irregular appearance of the exuberant granulation tissue.

A 16-year-old Warmblood gelding was referred to the Veterinary Hospital of Ghent University with a very large 3-month-old wound at the level of the metatarsus of the left hind limb (Figure 1). The injury had been sustained on fence wire and had been treated by the referring veterinary surgeon since the first day, but without success.

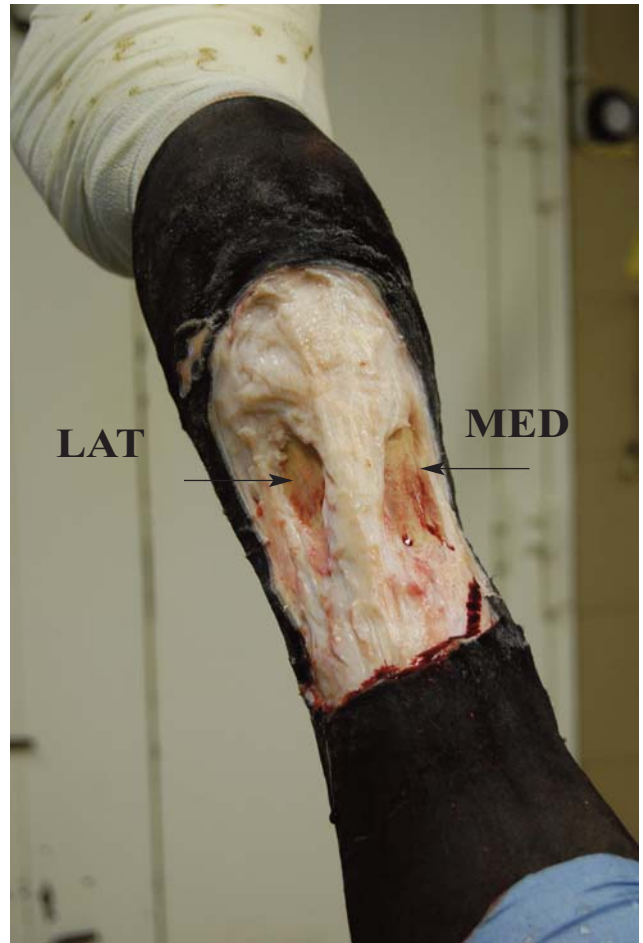
Figure 3. Intraoperative picture after all of the exuberant granulation tissue has been excised, the wound edges have been refreshed and the periosteal exostoses have been removed. There are two areas of exposed bone (arrows) – at the dorsolateral and the dorsomedial aspects of the wound.

Surgical debridement of the wound was performed under general anesthesia, with the horse in dorsal recumbency and with a tourniquet applied proximal to the hock. All exuberant granulation tissue was excised, the wound edges were refreshed and the periosteal exostoses were removed under fluoroscopic guidance. By the end of the procedure, two areas of exposed bone on the dorsomedial and dorsolateral aspects of the third metatarsal bone were visible, separated by a band of

scar tissue that had replaced the lacerated extensor tendon (Figure 3). After thorough lavage, the wound was covered with an antiseptic dressing (Kerlix®) and a full limb Robert Jones bandage was applied. Recovery from general anesthesia was uneventful.

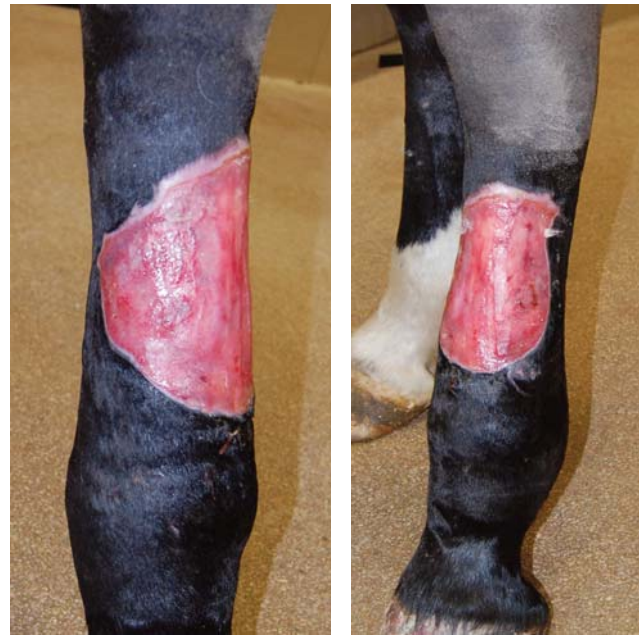
Figure 5. After 28 days (including an 11-day preparation period (with daily bandage changes with local application of fucidinic acid and silver sulfadiazine on alternating days), the granulation bed is now ready for skin transplantation.

Post-operative radiographic examination revealed successful removal of the periosteal exostoses (Figure 4). Because of the degree of preoperative wound contamination, the exposure of bone and soft tissues and the results of bacteriological examination from a post-operative sample, the horse was treated with oral doxycycline for 40 days (Doxyral 50%®, 20 mg/kg bwt, twice a day). Non steroidal anti-inflammatory drugs were administered for five days (Finadyne® paste, flunixin meglumine, 1.1 mg/kg bwt, once a day, orally). The wound was kept covered with a bandage and treated with different primary wound dressings according to the stage of wound healing. The bandages were changed every one to two days during the granulation period, before skin grafting. During the first ten days after surgery, an alginate dressing (Curasorb®) covered with an antiseptic gauze bandage (Kerlix®) was used for its absorbing properties and to stimulate granulation tissue formation, especially over the areas of exposed bone. By the seventh day after surgery, the dorsomedial aspect of the metatarsus was covered with healthy granulation tissue and by the eleventh day the dorsolateral aspect was also covered. Seventeen days after surgery, the wound was completely covered with smooth, homogeneous granulation tissue. In view of the size and the location of the wound, it was decided to accelerate further healing with a skin graft. Over the next 11 days, the wound was prepared for grafting according to the recommendations of Wilmink *et al.* (2006). This consisted of daily bandage changes with the alternating topical application of two different antibiotic ointments: silver sulfadiazine (Flammazine®) and fucidinic acid (Fucidin® 2%). Whenever it was indicated, the granulation tissue was cut back to the level of the skin. Twenty-eight days after the initial surgery, the wound was considered ready for skin grafting, even though it remained very exudative (Figure 5).

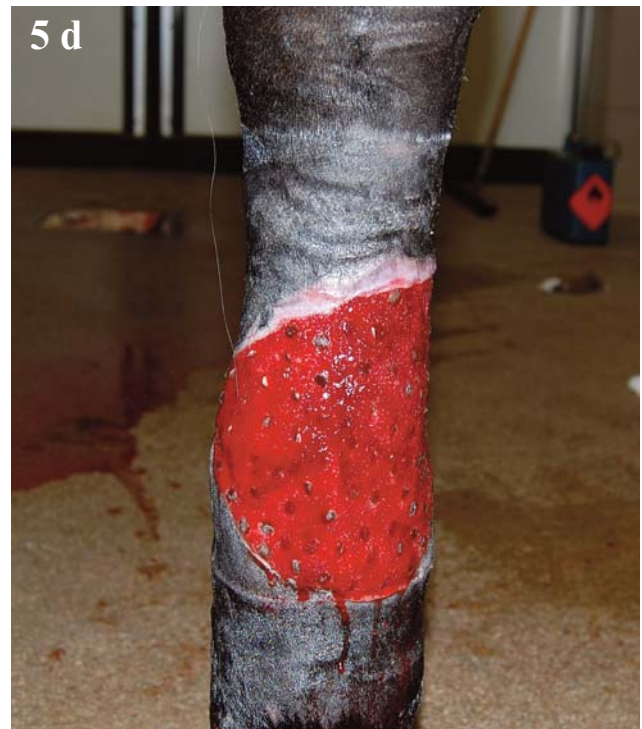
Figure 7. Appearance of the wound bed at the time VAC therapy was discontinued (d = days post skin grafting).

At bandage removal, a graft acceptance of nearly 100% was observed, with granulation tissue of good quality. Hypergranulation did not occur, but the surface of the granulation tissue was irregular, most likely due to suction of the tissue onto the foam (Figure 7). The wound was no longer excessively exuding. A remarkable decrease in the limb edema was also observed. In order to achieve homogeneous granulation tissue, an ointment containing antibiotics and corticosteroids (Fucidin® hydrocortisone, 20 mg/g fucidinic acid and 10 mg/g hydrocortisone acetate) was applied topically and the bandage was replaced for two days. During the epithelialization phase, the limb was continuously kept under bandage with hydrophylic polyurethane foam (Kendall™) as the primary wound dressing. The bandages were changed every four to six days during this period. After the VAC therapy, the granulation tissue remained of good quality and the grafts gradually epithelialized to coalesce with each other and with the wound edges (Figure 8). Recurrent localized swelling of the granulation tissue between the grafts preventing epithelialization was observed at the distal and medial aspects of the limb and was treated

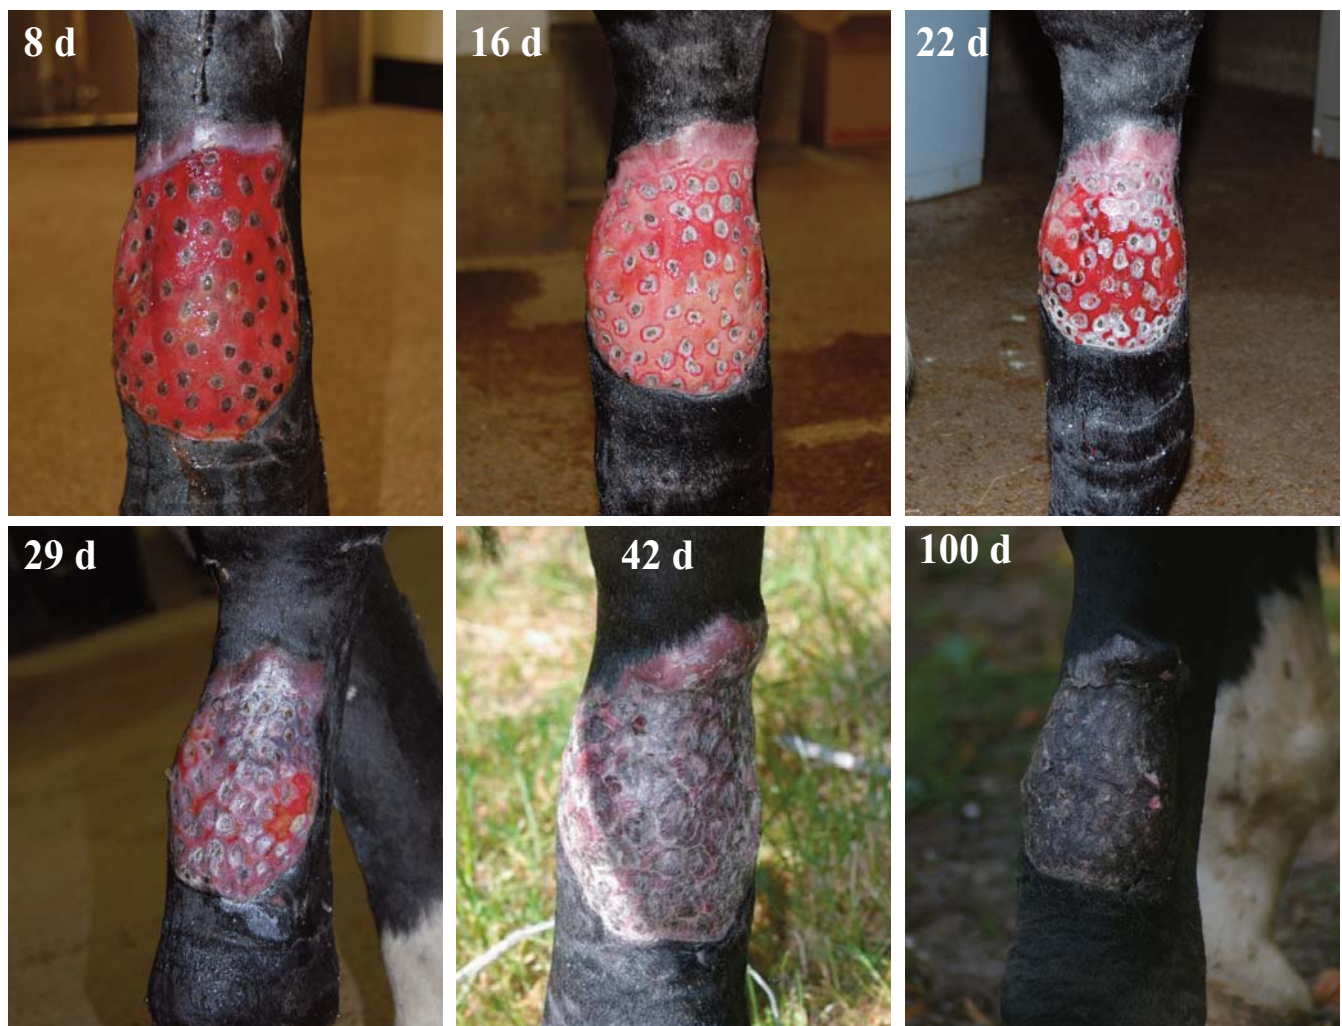
Figure 8. Progression of wound epithelialization after discontinuation of the vacuum therapy (d = days post skin grafting).

periodically with the Fucidin® hydrocortisone cream (never longer than two days). The horse was discharged from the clinic 37 days after the grafting procedure (66 days after initial surgery) and at this time he was walking comfortably, without limb swelling and with a wound that was almost completely epithelialized. Complete epithelialization was observed 42 days after skin grafting (Figure 8).
