# Challenges in introducing high-density interconnect technology in printed circuit boards for space applications

Maarten Cauwe, imec-Cmst, Zwijnaarde, Belgium Bart Vandevelde, imec, Leuven, Belgium Chinmay Nawghane, imec, Leuven, Belgium Marnix Van De Slyeke, ACB, Dendermonde, Belgium Alexia Coulon, Thales Alenia Space, Charleroi, Belgium Stan Heltzel, European Space Agency, ESTEC, Noordwijk, The Netherlands

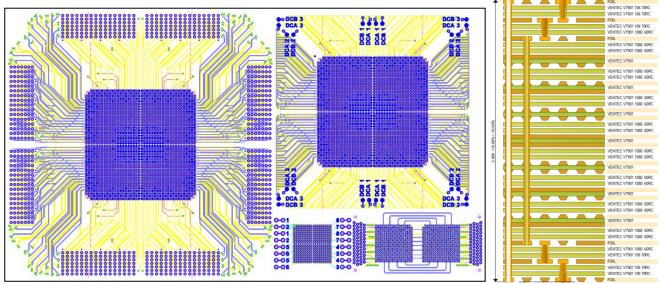
Figure 1 - BGA coupon with real and daisy-chain component fan-out for 1.0 mm and 0.8 mm pitch component (*left*) and build-up of the qualification test vehicle (*right*)

The BGA coupon (Figure 1) mimics (part of) an actual HDI PCB design and acts as "PCB" for the qualification test flow. The real component fan-out for 1.0 mm and 0.8 mm pitch components are based on the actual pin-out diagrams for the Xilinx Virtex 5QV FPGA and the Teledyne e2v EV12AQ600 ADC, respectively. Controlled impedance differential pair routing was applied

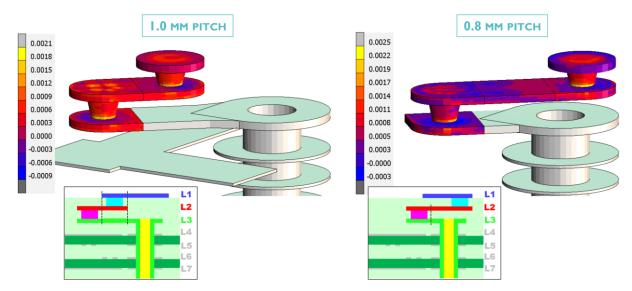
Figure 2. Positioning of the microvias with respect to the core via on the qualification test vehicle (1.0 mm pitch with both microvias off-set to the core via (*left*) and 0.8 mm pitch with the external microvia partially superimposed to the core via (*right*))

In the design of the BGA coupon, two different approaches for positioning the microvias are integrated (Figure 2). For the 1.0 mm pitch fan-out, both microvias are placed completely next to the core via. Due to the limited space, this approach was not possible for the 0.8 mm pitch fan-out. As a consequence, the outer microvia is partially superimposed to the core via.

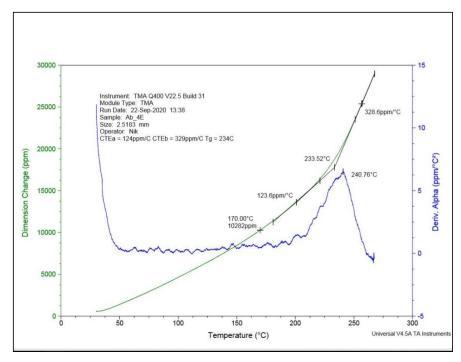
Figure 3. TMA measurement of the basic HDI construction using a polyimide resin system

PCBs for space applications are traditionally manufactured using polyimide as base material. The main advantage of a polyimide resin system is the high glass transition temperature (Tg), which is typically around 250 °C. This is above the SnPb reflow temperature of 230 °C, meaning very little damage is introduced when the PCB is submitted to assembly cycles and possible rework and repair. Alternative materials, such as high-Tg epoxy resin systems have a lower Tg compared to polyimide (160 - 180 °C). While the coefficient of thermal expansion in Z-direction (CTE<sub>z</sub>) for these materials increases significantly above Tg, the CTE<sub>z</sub> below Tg is often much lower than for polyimide resins system. HDI PCBs use thin laminate and prepreg layers in their construction, which are provided with relatively high overall resin content (volume ratio of resin to glass fiber). Regardless of the resin system, HDI constructions exhibit a higher thermal expansion in Z-direction due to the use of thin glass fiber styles such as 106 or 1080 [11]. For unfilled polyimide resin systems, the impact of switching to a high-resin content HDI construction on the overall CTEz is observed to be significant. Figure 3 shows a TMA measurement of the basic HDI construction using a polyimide resin system. While the Tg is estimated to be around 235 °C, the CTE<sub>z</sub> below Tg is measured to be in excess of 120 ppm/°C (datasheet value of 50 ppm/°C). Finally, polyimide resin can suffer from embrittlement after the multiple laminations required for an HDI PCB construction.

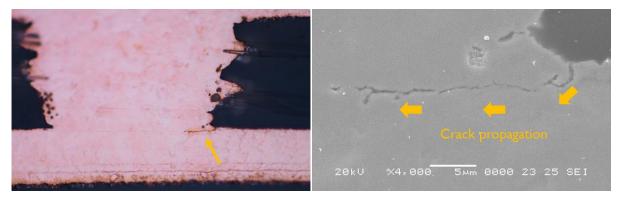
Figure 6. Optical (left) and SEM (right) inspection of microvia failure after IST

In the frame of the basic HDI qualification, late microvia failures were encountered during IST. Two coupons failed at about 300 cycles from room temperature to 210 °C, following six times preconditioning to 230 °C and 500 cycles at 170 °C. Failure analysis confirmed that the cracks originate at the edge of the contact area between the microvia and the target pad and preferably propagate along the plating interfaces (for example, between the electroless and galvanic flash plating in the case of Figure 6). This failure location corresponds to the areas of highest stress in the microvia, as can be seen from the modelled strain values in Figure 2 (areas of highest stress indicated in yellow). Note that this failure mode is different from the weak microvia interface failures from the IPC alert, which typically manifest themselves during the first few reflow cycles (or "*preconditioning*" in IST terminology). In-depth process optimization resulted in reinforcing the plating multiple ESA qualified PCB manufacturers was performed [19]. No failures were observed for the microvias at 0.8 mm and 1.0 mm pitch from any of the manufacturers after 1000 cycles to 210 °C.

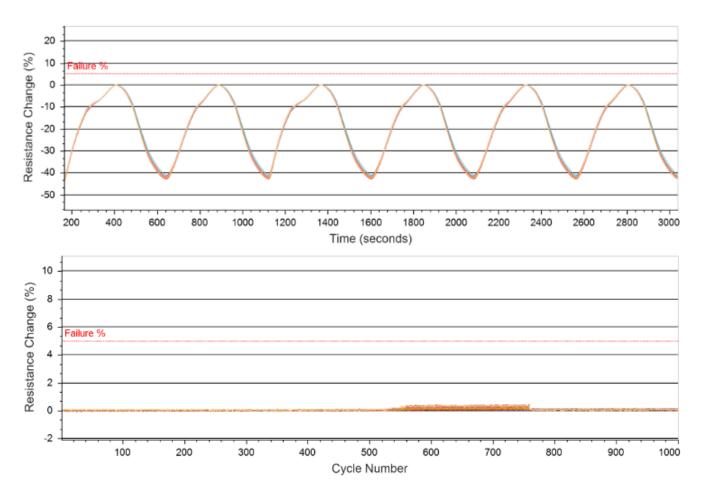
Figure 7. Test results for individual microvia daisy chains using IPC-TM-650 2.6.27B (*top*, six times reflow to 230 °C) and 2.6.7.2C (*bottom*, 1000 cycles from -55 °C to +145 °C)

D-coupons from the same batch of the qualification test vehicle for the basic HDI technology were subjected to convection reflow assembly simulation (six times reflow to 230 °C), followed by air-to-air thermal shock. A similar temperature range as for thermal cycling was applied (-55 °C to +145 °C) for up to a 1000 cycles. The daisy chains with individual microvias (no core vias present) did not show any resistance increase after reflow simulation nor after 1000 thermal shocks (Figure 7). D-coupons with propagated structures from the same panels showed failures in the core vias after 650 and 570 cycles on average, for 0.8mm and 1.0mm pitch respectively. The failures observed during IST were not observed during convection reflow assembly simulation and air-to-air thermal shock testing. The reason for this can be found in the lower maximum temperature that was adjusted to represent the standard ECSS chamber thermal cycling profile (from -55 °C to +145 °C). Future work includes retesting at higher maximum temperature, as per the standard protocol, to 10 °C below Tg. In addition, the absence of core vias in the individual microvia daisy-chains results in lower stress on the microvia.
